INVESTIGATION OF ENVIRONMENTAL DAMAGES CAUSED BY EXCAVATED MATERIALS AT FOREST ROAD CONSTRUCTION IN THE MEDITERRANEAN REGION OF TURKEY

SENTURK, N.^{1*} – OZTURK, T.¹ – INAN, M.² – BILICI, E.³

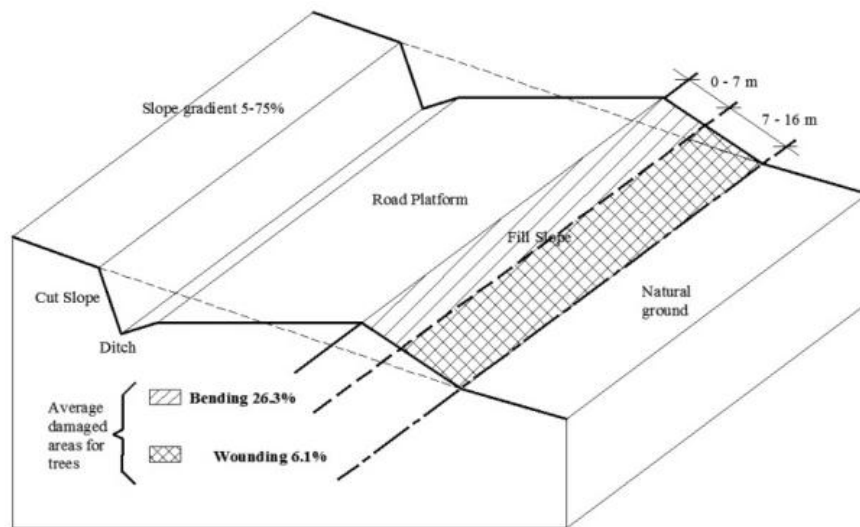
Some of the cross sections did not have any damaged trees, whereas the others had damaged trees (*Fig. 3*). The damaged trees usually had bending and wounding damages (*Figs. 4 and 5*). The number and rate of the damaged trees in the study area is shown in *Table 3*.

Figure 3. Determination of cross sections along the road alignment

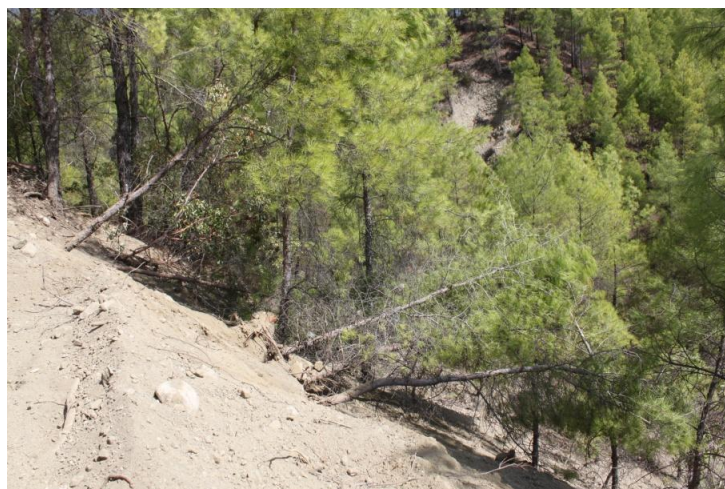
Figure 4. Bending damages of trees

- Bulldozers should be used in forested areas with less than 45% ground slope. Environmental damage is increased in areas where slope is higher.
- A buffer zone should be maintained between a forest road and a stream. The buffer zone protects the stream bed from excavated materials.
- Damaged trees should be removed from sensitive areas where bark beetles are abundant. Especially the wounded trees will increase the number of bark beetles. This situation is very dangerous for sensitive forest areas.

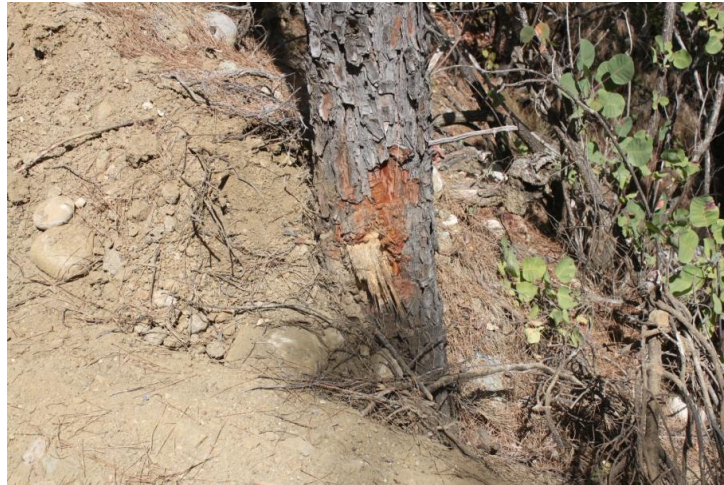
Figure 5. Wounding damages of trees

The wounding of the tree barks is a very serious issue for this forest region. For many years, bark beetles have been devastating this region. The damage caused by bark beetles is denser especially on *Pinus brutia*. The environmental damage may be increased in these regions due to bark beetles. In addition, direct economic losses are rising due to the timber quality lowered by bark beetles.

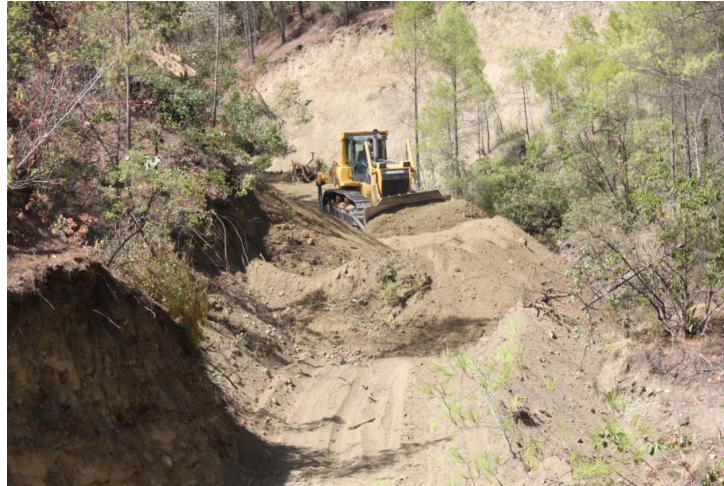
All the excavated materials were dumped down the side of the roadway by the bulldozer. As the second type of environmental damage, the stream bed was filled with excavated materials. In this case, the direction of the stream flow was diverted. This change was very serious in terms of freshwater ecology, fish health, and rerouted stream beds (*Fig. 6*).

Figure 6. *The fill with excavated material of stream bed*

Filling stream beds with excavated materials increases the risk of erosion in this area especially in the rainy season. The main reason for dumping excavated materials over the stream bed was the fact that the forest road was very close to the stream. A buffer zone should be allowed between a road and a stream so that the stream can be protected from excavated materials. According to Akgül, the width of a buffer zone should be increased depending on the slope rate. The width of a buffer zone ranges between 25 and 150 m on productive forest areas (Akgül, 2012). Stream beds are protected from flow of sediments by buffer zones, and thus, the speed of rainwater is reduced in such areas (Wenger, 1999; Wood and Armitage, 1997).
