# Causes of dike deterioration – environmental and anthropogenic effects

Zsombor Illés<sup>1,2</sup>

**Keywords:** pavement crack survey, dikes, swelling-shrinking clays, safety aspects, climate change

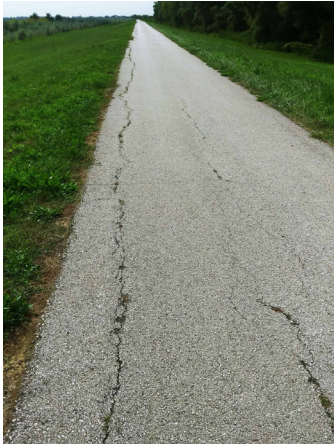
**i) Parallel**  
Tisza, Left bank 3+600

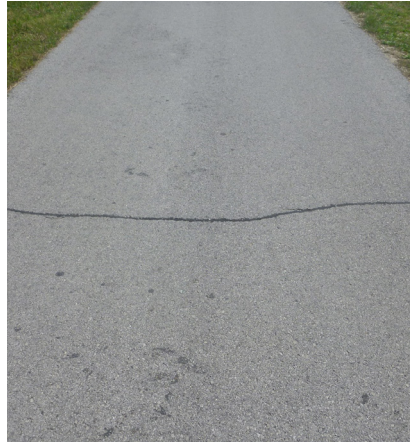
**ii) Perpendicular**  
Moson-Danube, Left bank 16+173

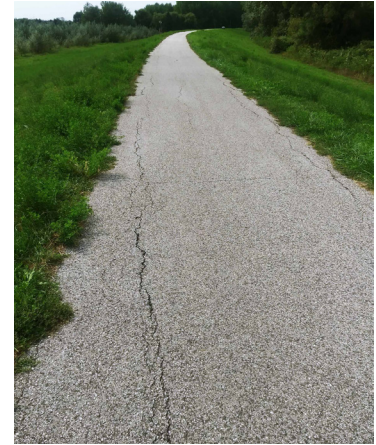
**iii) Parallel + Perpendicular (a)**  
Tisza, Left bank 2+500

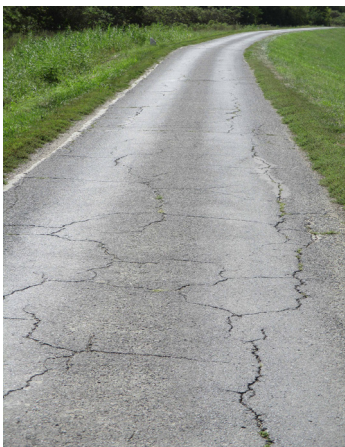
**iii) Parallel + Perpendicular block cracks (b)**  
Tisza, Left bank 55+300

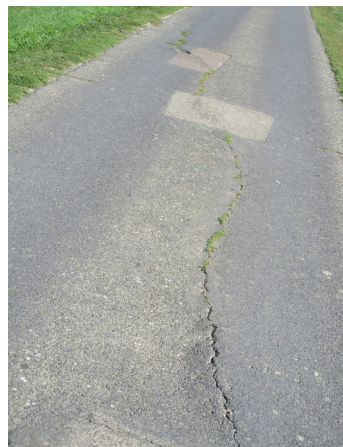
**iv) Winding**  
Tisza, Left bank 56+250

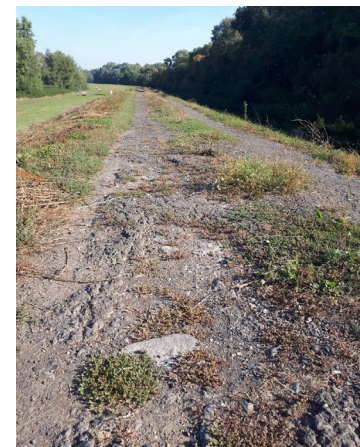
**v) Undetermined**  
Tisza, Right bank 41+210

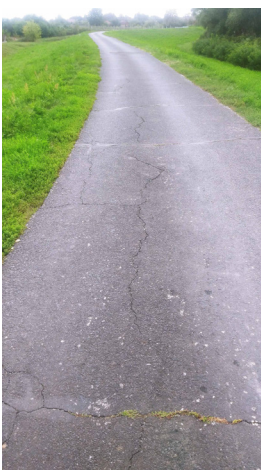
**i) Thin (hairline)**  
Tisza, left bank, 0+690

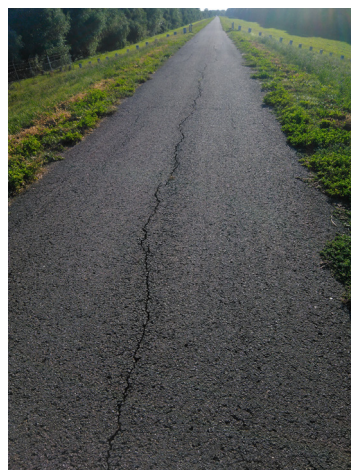
**ii) Medium**  
Tisza, right bank, 7+230

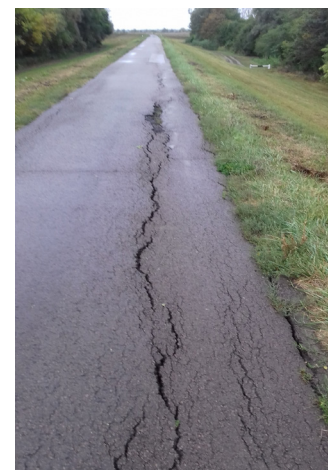
**iii) Thick (sturdy)**  
Tisza, right bank, 126+260

pavement deflection (Jouben 2014), mark soils with volume variable properties in the embankments. The thickness of the crack was measured by the surveyors, measured or approximated from the photos. The crack width categories are demonstrated in Figure 3.
