Dike failures in the Carpathian Basin

László Nagy

Department of Geotechnics and Engineering Geology, Budapest University of Technology and Economics,
Budapest, Hungary

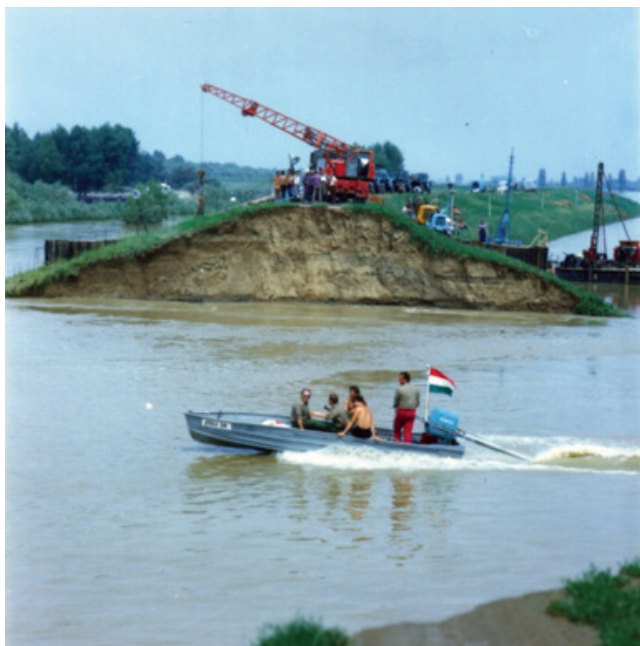
Figure 4 | Dike breach in 1980 in the Körös valley
Source: ABKSZ

Undoubtedly, most dike failure mechanisms (77% of all dike failures with known mechanisms) were due to erosion after the failure (see e.g. the cases in *Fig. 4, 6*). This failure mechanism means the occurrence of a water level higher than the design water level or the construction level of the dike (*Table 1*).

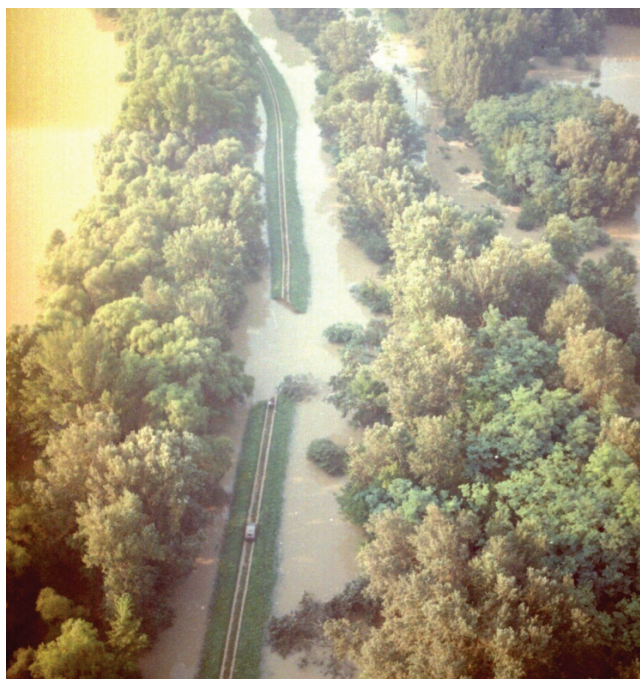
Figure 9 | Dike breach at Surány (Danube right bank) 09 August 1991
Source: ABKSZ

- At any time of the year, flooding can occur that could lead to a dike failure (*Fig. 9*).
- The diminishing number of failures implies that flood control in Hungary has attained a fairly high level, though not all hazards have been eliminated yet;
- The proportion of failures caused by overtopping has decreased and reveals a diminishing trend;
- The likelihood of failures caused by overtopping, however small, is confined presently to streams carrying a small flow;
