# Causes of dike deterioration – environmental and anthropogenic effects

Zsombor Illés<sup>1,2</sup>

**Keywords:** pavement crack survey, dikes, swelling-shrinking clays, safety aspects, climate change

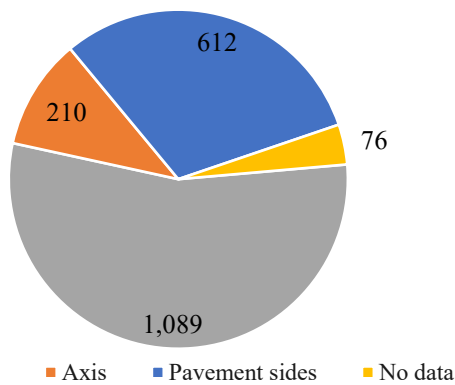
**Figure 6** | Summation of the location of cracks at the paved cross-section  
Source: Nagy, 2019

If the pavement at the central strip and at least one of the side strips were fissured, the whole cross-section was considered fissured. This consideration may indicate that the entire cross-section is fissured in more than half of the cases, as presented in Figure 6.

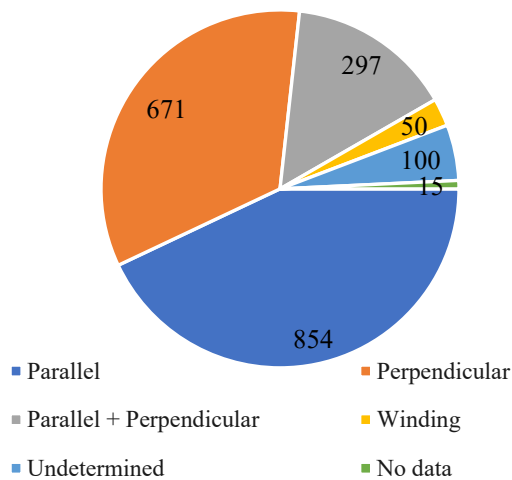
**Figure 7** | Proportion of crack direction compared to the axis of the pavement  
Source: Nagy, 2019

The ratio of the six crack direction categories (see Figure 2) are presented in Figure 7. More than a third of the cracks are parallel with the road axis.

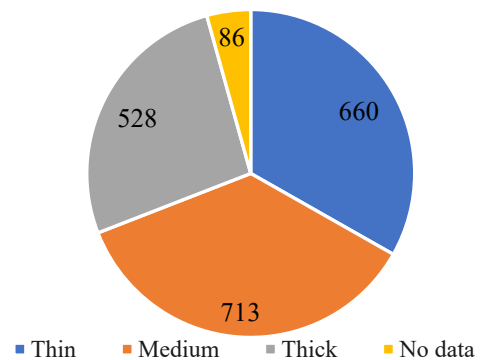
**Figure 8** | Summation of each crack width category  
Source: Nagy, 2019

The ratio of the demonstrated crack width categories is given in Figure 8.

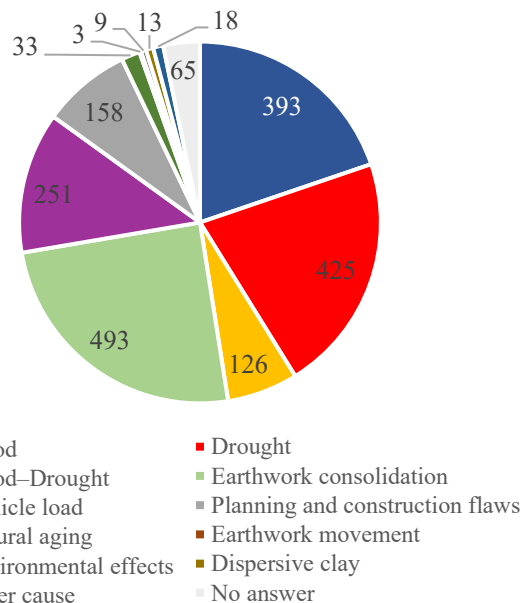
**Figure 9** | Primary causes of the flood protection embankment fissures  
Own source

The primary causes of the fissures identified by the pavement survey of the flood protection embankments are given in Figure 9.

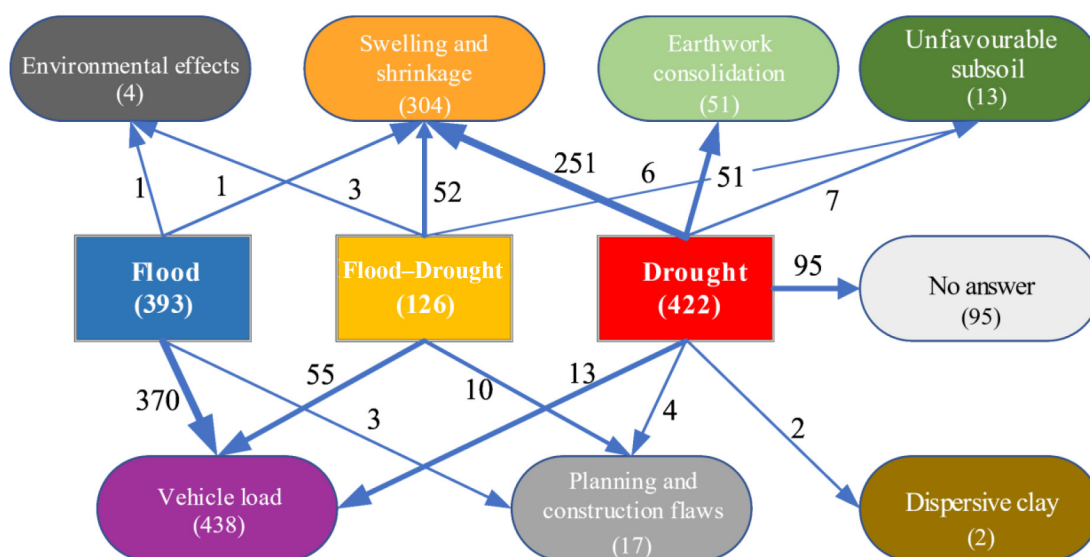
It is challenging to visualise the connection between the primary and secondary causes responsible for the pavement fissure development of the dikes. Only those cases were featured where the primary and the secondary cases differed (944 out of 1,987). The connections are presented in a graph (see Figure 10). The rectangles represent the primary causes (Flood, Drought, Flood–Drought), while the horizontal ovoids are the secondary causes. Figures 9 and 10 clearly show that the effect of droughts is as concerning as floods.

Figure 10 | Relation between the primary and the secondary causes  
Own source

mary cause and swelling and shrinkage as a secondary cause are closely linked (Figure 10).

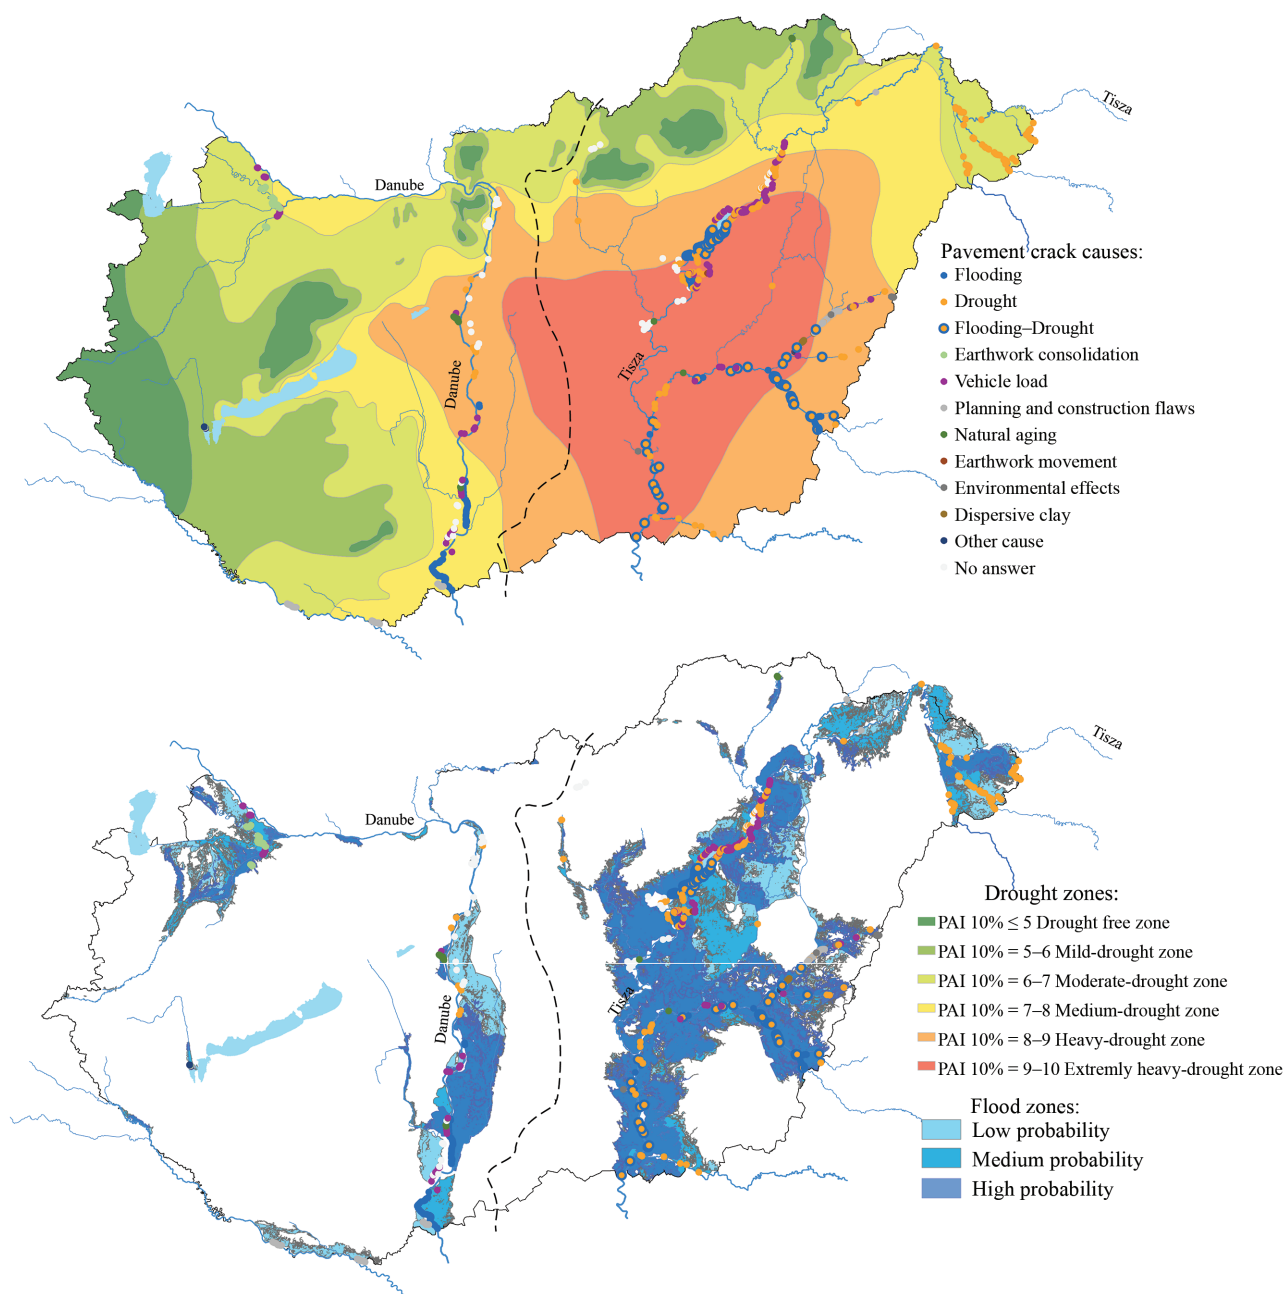
The fissure's location and the primary cause are marked on Hungary's drought and flood probability maps (see Figure 11). The driest region of Hungary is the Hungarian Great Plain, which falls into medium-drought, heavy- and extremely heavy-drought zones – approximately 40% of Hungary's territory and 75% of the agricultural areas in the country. It is more or less 28,000 km<sup>2</sup> (Pálfai 2004). On the other hand, flood probability zones occupy the Great and the Small Plain, where the rivers have vast areas to flood in case of a dike breach.

Figure 11 | Aridity and flood probability maps of Hungary (provided by OVF) with the coordinates of the pavement cracks  
Own source

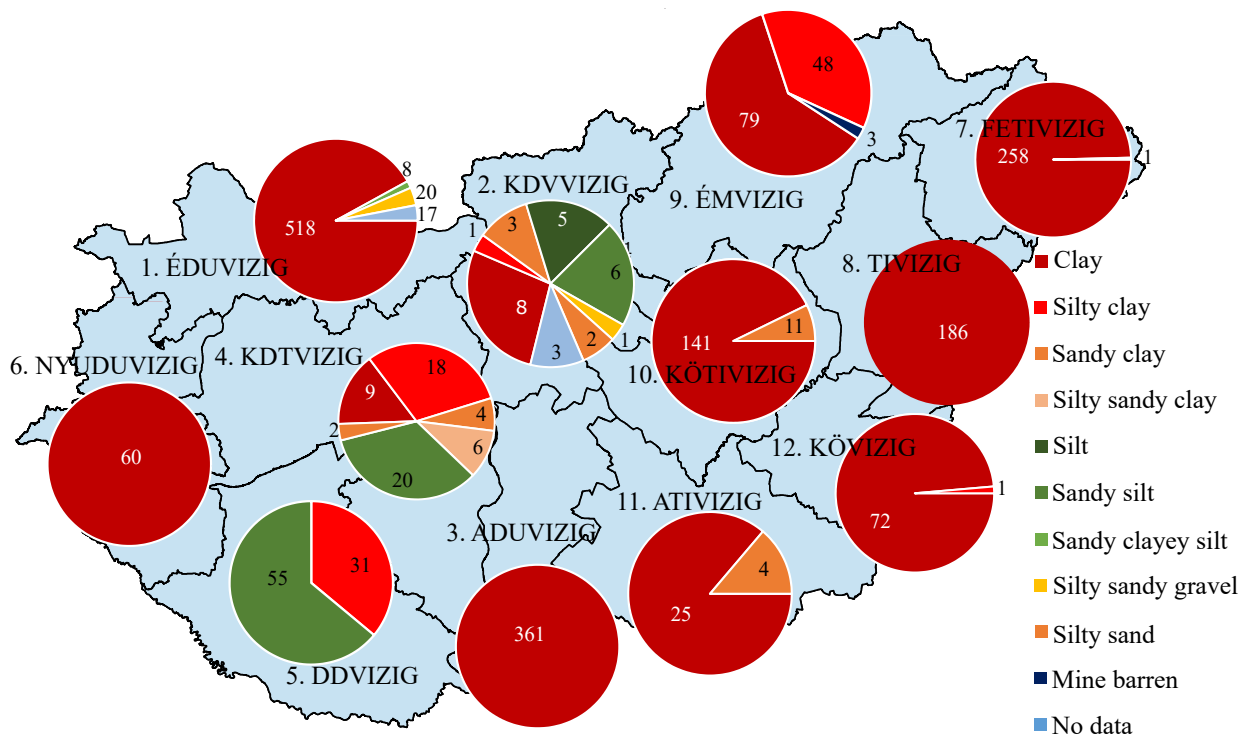
Figure 12 | Dike material under the cracked pavement section at each water directorate  
Source: Illés–Nagy–Antal 2022

Figure 12 shows the fill material under the pavement cracks, broken down by water directorates. In the Tisza

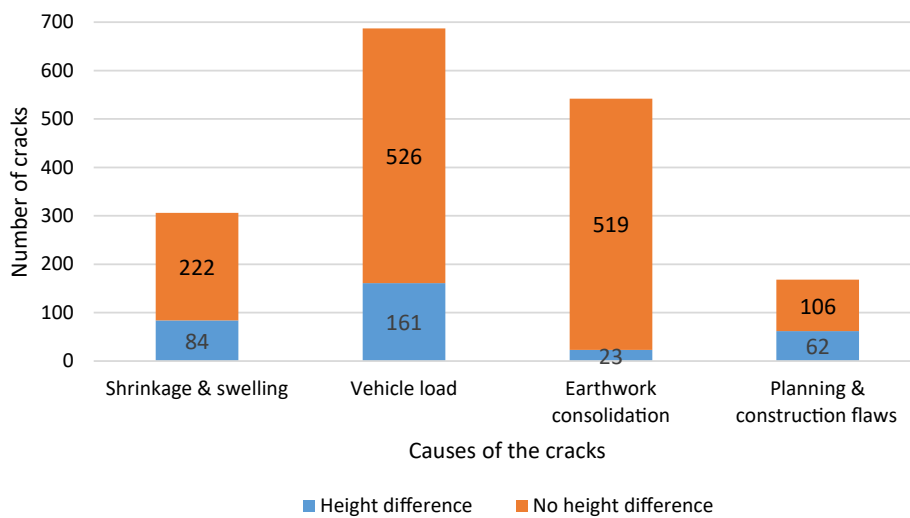
**Figure 13** | Causes of the pavement cracks and number of cracks in each group with a height difference

Not just the orientation of the crack but also the height difference between the two sides of it was documented as an indication of uneven settlement or heave. *Figure 13* shows the number of cracks with height differences among the four major secondary causes of fissure formation. *Figure 14* indicates the height difference distribution of these cracks, marked by the box plots.

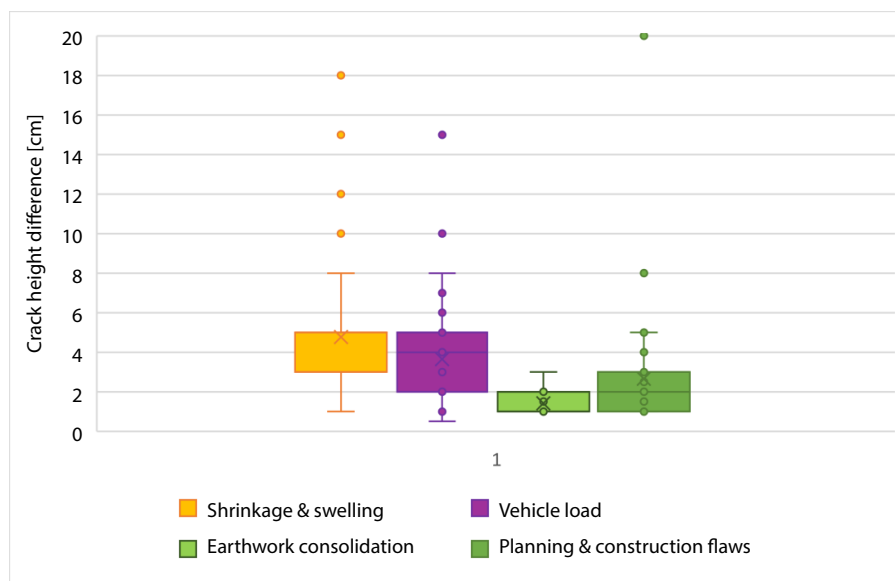
**Figure 14** | Crack height difference in the case of the four most important secondary causes
