Geomorphology and environmental history in the Drava valley, near Berzence

ISTVÁN VICZIÁN¹ and CSILLA ZATYKÓ²

Abstract

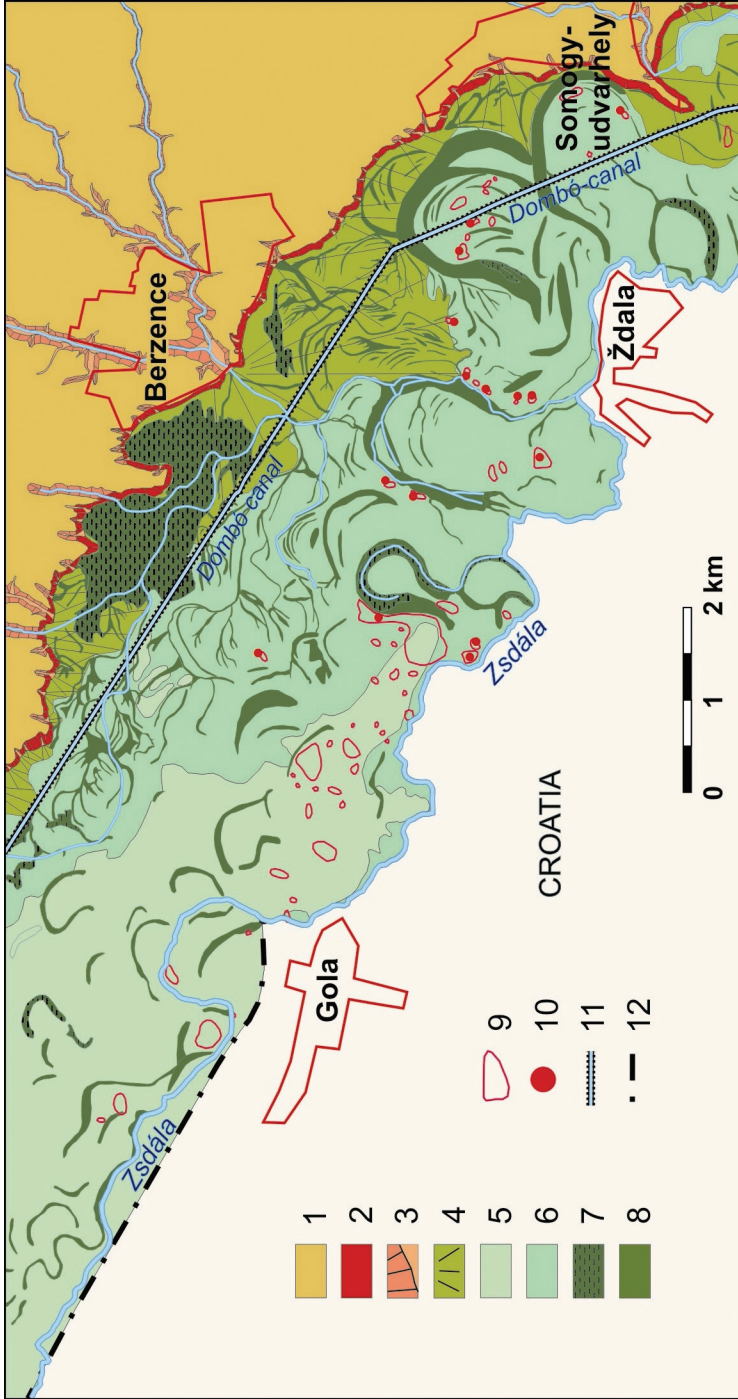
Fig. 2. Geomorphological map of the study area with archaeological sites from the Medieval Period. – 1 = alluvial plain with wind-blown sand forms; 2 = escarpment; 3 = stream valleys and gullies; 4 = alluvial fans; 5 = higher alluvial plain; 6 = lower alluvial plain; 7 = wetlands and marshy areas; 8 = low-lying paleochannels and channels of the perennial and ephemeral streams; 9 = archaeological sites from the Medieval Period; 10 = Dombó canal; 11 = archaeological finds related to iron smelting activity; 12 = Hungarian-Croatian border

The alluvial plain can be divided into two geomorphological units (Figure 2). The area at a lower elevation is the *lower alluvial plain*. North of it, at a slightly higher position is the *higher alluvial plain*. Each of the relict floodplain landforms has distinct sediments. The abandoned channels are filled up by fine sediments (silt, clay), the point bars are built up by sandy gravel, while the scroll bars are characterized by sandy and silty sediments. The sandy sediments in the alluvial fans of the streams originate from Inner Somogy.

Abandoned meanders of the Drava are well recognizable in the lower alluvial plain, especially on the territory situated between the Zsdála stream and the settlements Berzence and Somogyudvarhely (Figure 2). The location of

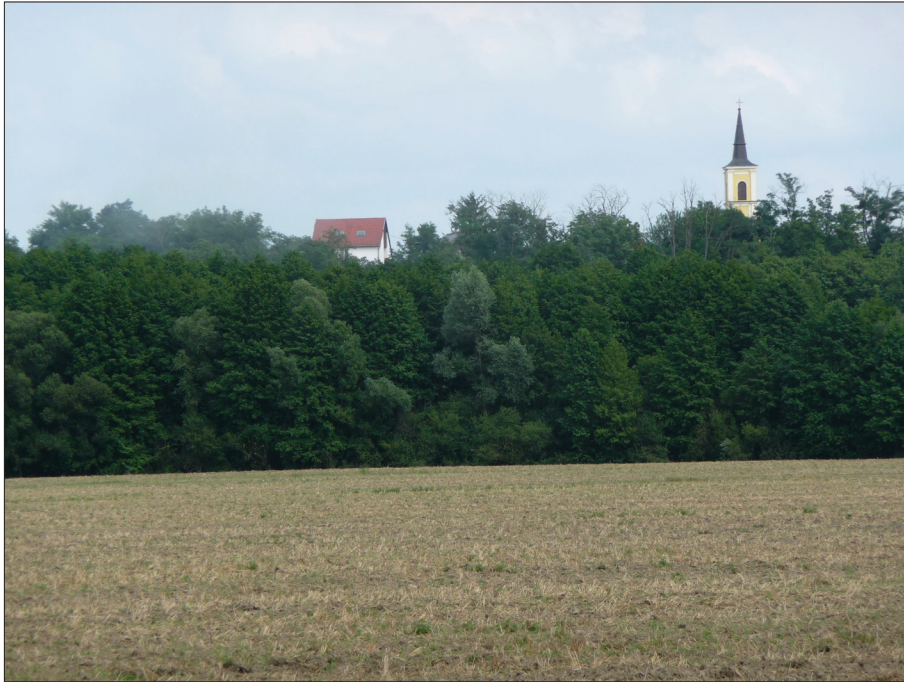
Photo 1. Escarpment at Somogyudvarhely. Photo by VICZIÁN, I. 2010

The escarpment, which forms the boundary between the two micro-regions, was developed in the late Pleistocene and early Holocene, when its profile was sapped and eroded by the Drava. The landforms of former river channels are quite recognisable at the foot and in the body of the scarp (*Figure 2*). Under the scarp, there are alluvial plains of low relief with streams that divide and flow in an intricately branching pattern. In some places they form wetlands and

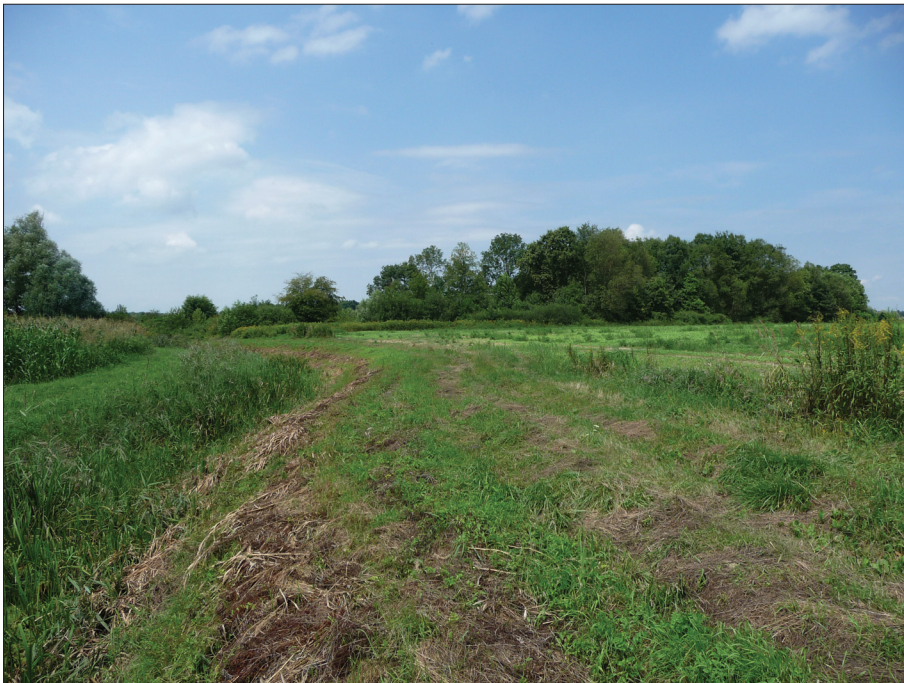
Photo 2. The Zsdála stream bed (on the left) and a former meander surrounded by forest (in the background). Photo by VICZIÁN, I. 2010

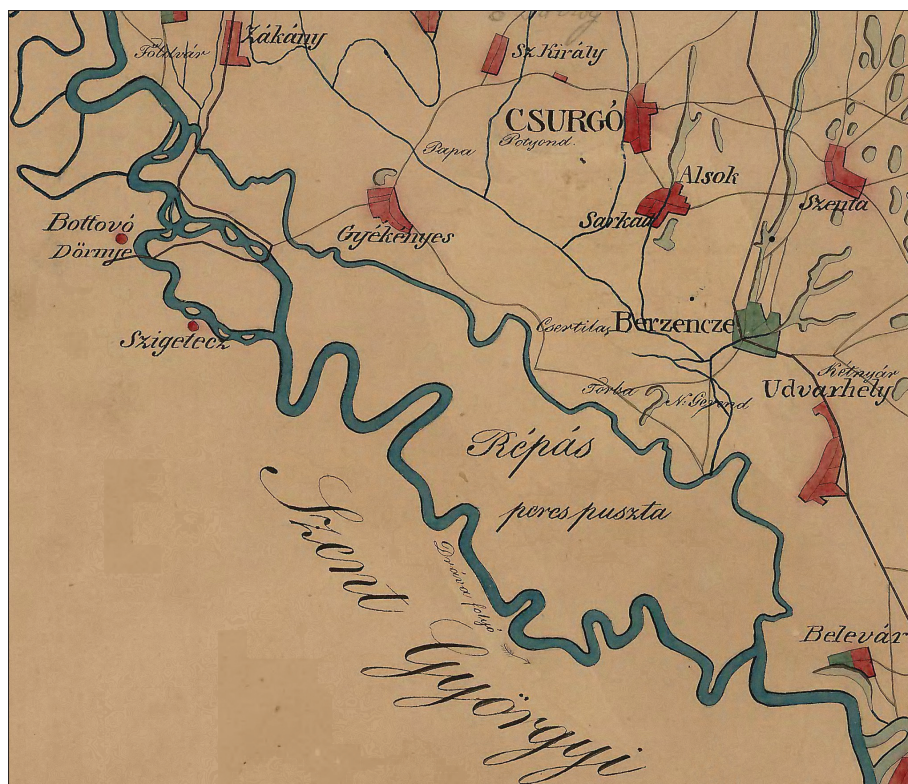
Fig. 3. Fragment of a map from 1850 showing the Zsdála stream as a branch of the Drava (OSZK – TK 1851)

The question arises whether the Zsdála stream used to be a branch of the Drava during the Middle Ages and how much impact the Drava's floods had on the area. On several maps, found in the collection of the National Széchényi Library, the Zsdála stream appears as a branch of the Drava, for instance on the map TK 2149 from 1685, on TK 1119 from 1788 and on TK 1851 (Figure 3) from 1850. The area enclosed by the river and the stream is shown as Répás island on many maps. HUNFALVY, J. (1865) writes about the Drava: "... it often splits into several branches and embraces smaller or larger islands. ... Among its largest islands are Répás island near Berzence, southeast of Novoszelló Légrad, ..." The first military survey map from 1784 shows the

Zsdála as a stream taking its source from the hills near Zákány. The same is illustrated on several other 18–19th century maps. It should be noted that the Zsdála stream used to run in an early Holocene Drava bed or branch and presumably it continued to be associated with the river during the second half of the Holocene as well. The heavily filled-up streambed today approaches the river by barely one kilometre near Gyékényes in the west. Several detailed archive maps present the Zsdála flowing into the Drava south of Zákány (from 1786: MOL S 12 Div 13 No 70:7 and 70:8, from 1793: MOL S 12 Div 13 No 237:1 and 237:2, from 1802: MOL S 12 Div 18 No 72:2 and 73:2, from 1822: MOL S 12 Div 12 No 24).

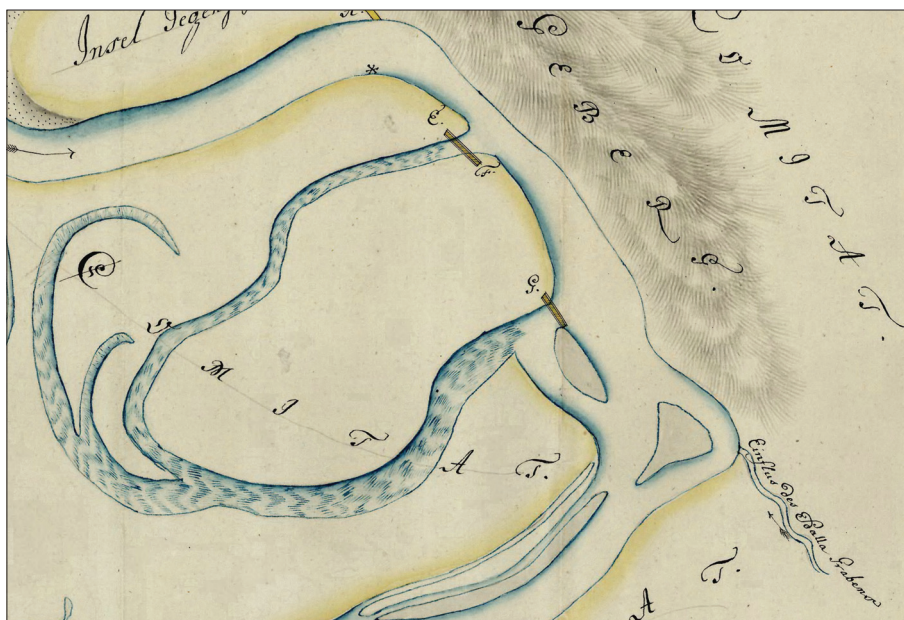
Fig. 4. Map from 1786 shows the connection of Zsdála and Drava at Zákány “Einfluss (*Einfluss*) der Sdalla Grabens” = the inflow of the Zsdála bed (MOL S 12 Div 13 No 70:7)

On the map from 1786 the “Einfluss (*Einfluss*) der Sdalla Grabens” (the inflow of the Zsdála bed) appears with a small arrow, indicating the direction of flow towards the Drava (*Figure 4*). Based on these, the water flowing into the formerly filled-up Drava bed probably reached the river partly south of Zákány and partly, continuing along today’s Zsdála bed to the east, it flowed into the Drava at Bélavár.

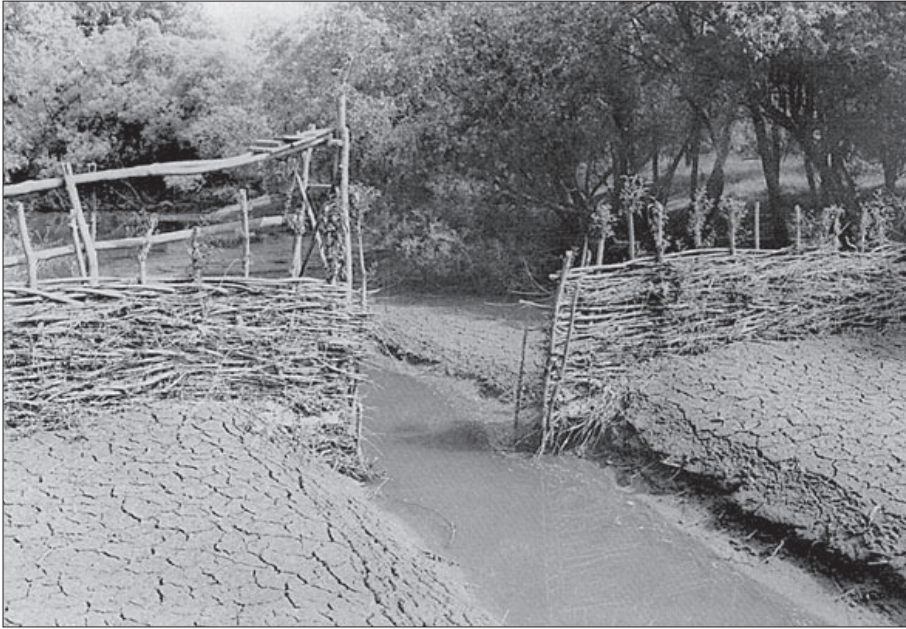
Photo 3. Barrier device built of wattle, used on sluggish water of the inundation area. Bés (Ung County). Photo by BELLON, T. 1986. (SZILÁGYI, M. 2001)

In the following, those features of ponds and fishing places will be discussed that emerge from the source itself. The document refers to ponds usually as *piscina*, but the terms *geregye* and *strugh* are also frequently mentioned in the terrier. The term *strugh* is derived from the slavic word *struga*, meaning watercourse, or bend (Kiss, K. 1978). Referring to *geregye*, the document refers to it as *captura piscium*, meaning fish trap. The form of the often mentioned *geregye* is known from modern, ethnographic analogues (*Photo 3*). It is the simplest type of barrier device built of pales, sods and soil and used in fisheries of shallow and sluggish waters of inundation areas. With the help of this weir, the water is closed in its full width, and the fishes that swim up into the oxbow lakes and meanders during the time of inundation can be closed and preserved for a long time (BELÉNYESY, M. 1953; SZILÁGYI, M. 2001). According to the description of Mathias BÉL from the 18th century, the fishermen drove the backwater backwards when it started to flow towards the river, and at the same time they built a barrier behind them, so the water filled with fish was funnelled to another place closed by the barrier (BÉL, M. 1941).

Based on our source from 1377, the above-described or a very similar device is presumed to have existed on the inundation area of the Drava. During high stages the oxbow lakes and abandoned channels were flooded and as the water level fell, the *geregye* concentrated and funnelled fish to a

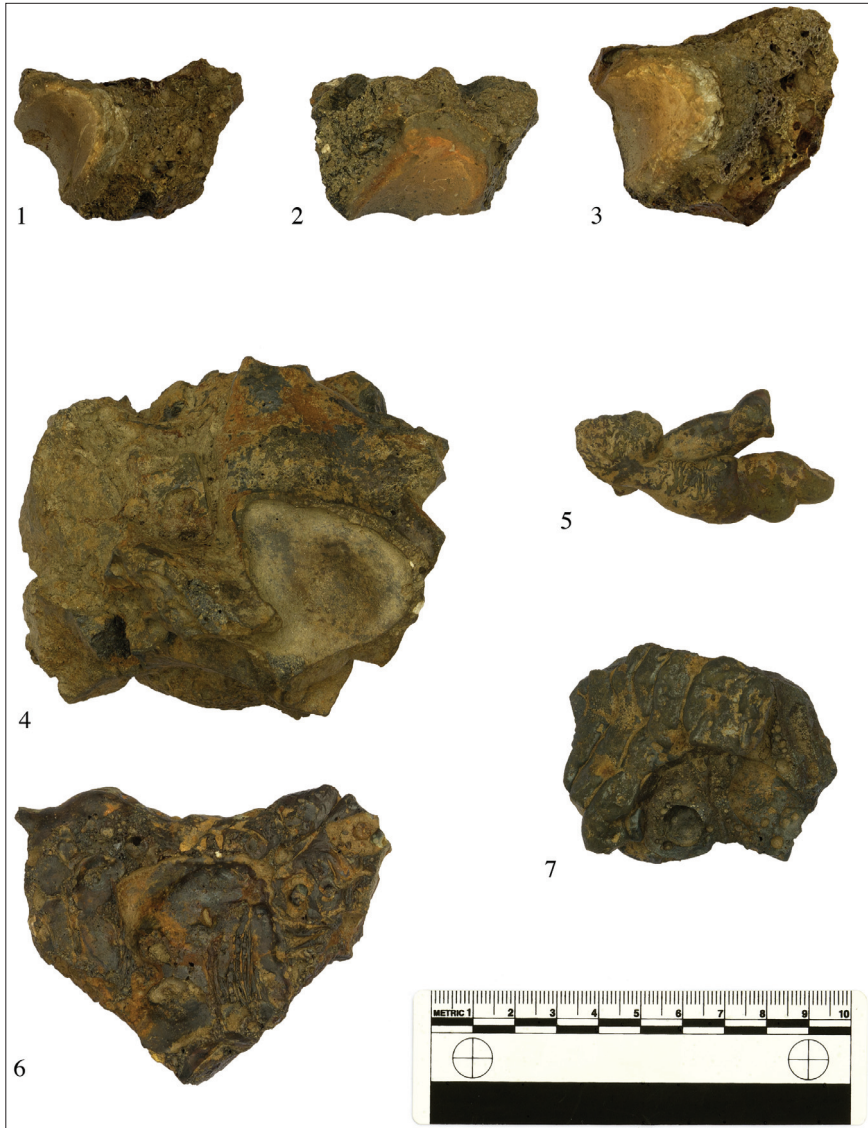
Fig. 5. Pieces of tuyères embedded in slag (1–3); pieces of slag (4–7). Photo by ΖΑΓΥΚÓ, Cs.

rivers. Additionally, several sites from the Arpadian age on the lower terrain contained finds related to iron smelting activity, such as slags, iron blooms and pieces of tuyères (*Figure 5*). The formation of bog iron is typical in reductive environments, in areas with high ground water level, swampy and marshy lands, just as this area used to be during most of the Holocene. The presence of iron-based industrial activity during the Arpadian age, where attention was focused on the exploitation of alluvial iron ores, demonstrates the further use of wetlands as a resource for activities other than fishing.

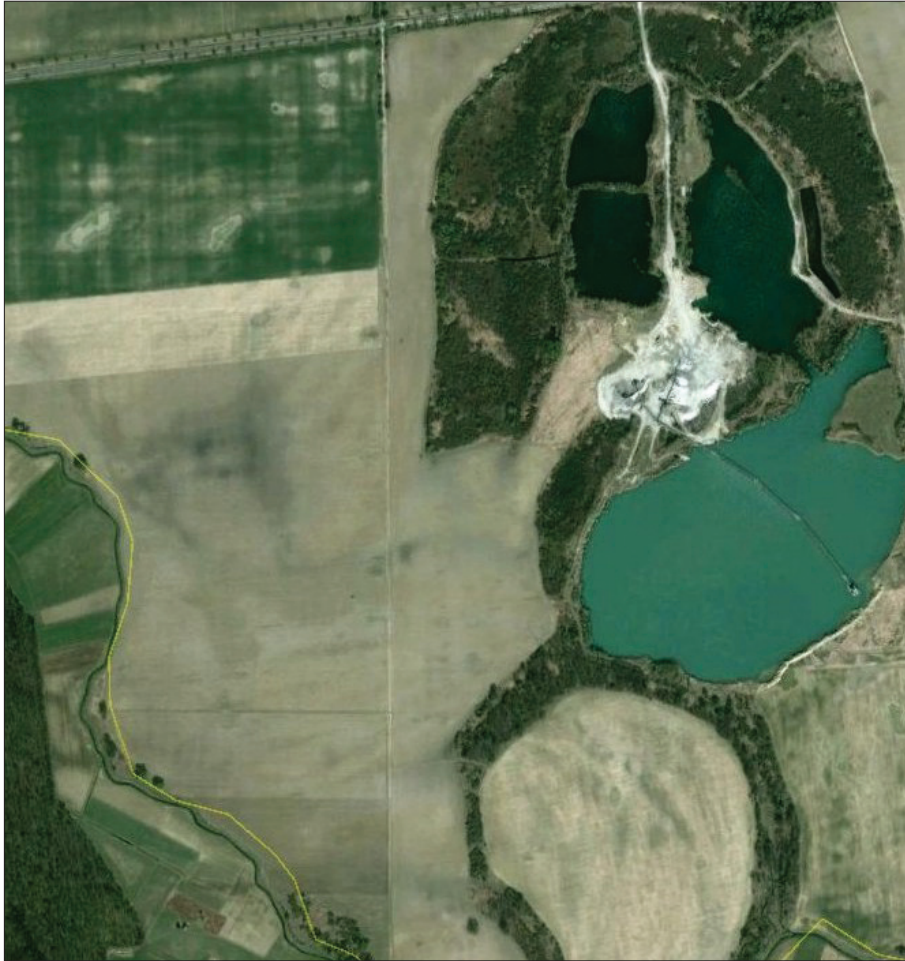
Fig. 6. Traces of a medieval settlement within the township of Berzence on a satellite photograph. Source: Google Earth 2008

It contains finds mainly from the 15th–16th centuries in its southern part and potteries from the 12th–14th centuries in its northern area. A satellite image of the site (Figure 6) indicates a large brick building traced during the field walking, with lines of streets and a road leading towards an oxbow lake on the east (today's pebble quarry). Smaller ponds might have formed at the foot of the escarpment on plains without an outlet and in the other meanders, although these are less probable.
