## Adaptation of land use based on the assessment of inundation risk in the Kapos Valley, Southwest Hungary

PÉTER GYENIZSE<sup>1</sup>, DÉNES LÓCZY<sup>1</sup>, JÓZSEF DEZSŐ<sup>1</sup>,  
ERVIN PIRKHOFFER<sup>1</sup> and MARCIN SŁOWIK<sup>2</sup>

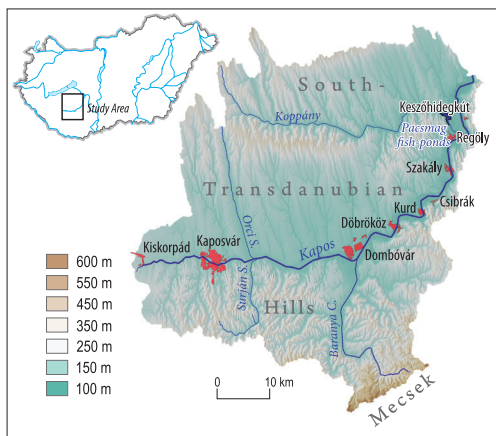
*Fig. 1.* Topography of the Kapos catchment.  
Source: DEM with 10-metre resolution, DDVÍZIG.

The medium-sized catchment of the Kapos River covers 3,295.4 km<sup>2</sup> in the South Transdanubian Hills region and the Mecsek Mountains (Lóczy, D. 2013 – *Figure 1*). The Kapos River is 112.7 km long. The morphological floodplain (without that of the tributaries) extends over 104.2 km<sup>2</sup>, which makes up 3.3 per cent of the total catchment area. Consequently, runoff from the hilly parts of the catchment is concentrated in an area of limited extension.

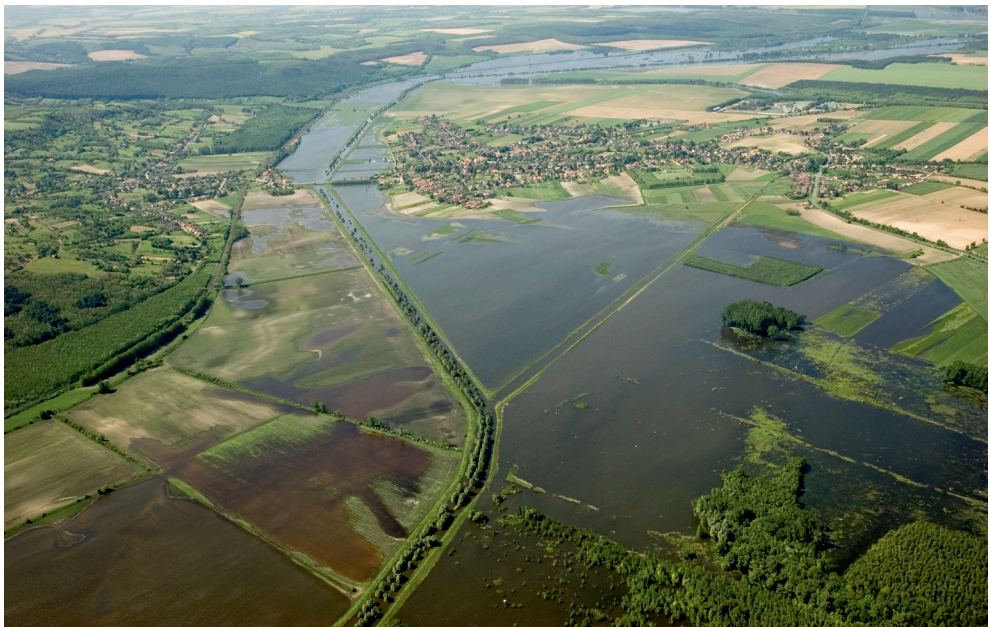
*Photo 1.* The Döbrököz area on an aerial photograph (May 2010) taken by the Pécs Aeroarchaeology Theca (Photo by SZABÓ, M.)

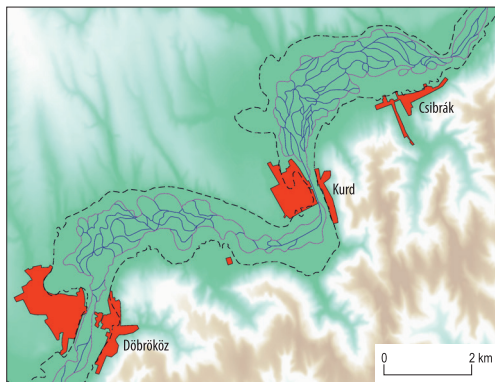
Fig. 2. Reconstruction of old Kapos channels in the Döbrököz and Kurd–Csibrák embayments (38–51 river km) for the early 19<sup>th</sup> century (drawn by GYENZISE, P. after information from military survey maps). The black dashed line indicates the boundary of the morphological floodplain and the magenta enveloping lines the channels farthest away from the valley centre line.

The map reconstruction of the groundplan of the Kapos paleochannel system presents an intricate low-energy anastomosing/braiding pattern with some meandering channels (Figure 2). There is a zone along the floodplain margin where paleochannels could not be mapped. This fact can be explained by intensive sheetwash from the neighbouring slopes onto the floodplain. The washed-down loess deposits obliterate the traces of paleochannels from the surface and also raise the elevation of the ground surface. This has important implications for land use (see later).

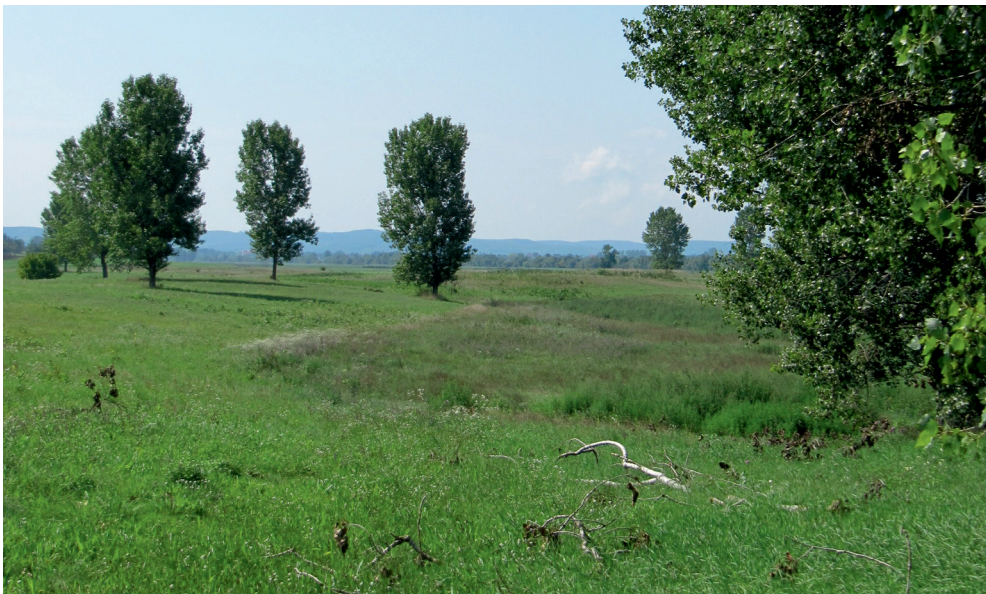
*Photo 2.* The natural levee at Szakály with a row of poplars on the right bank of the Kapos River (Photo by Lóczy, D.)

50 m distance, a relatively high natural levee of sand rises (*Photo 2*). The functioning of this landform of natural origin as a flood-control structure would also improve the water supply of the floodplain. To the space between the present dyke and the natural levee (which was probably also deepened as a navvy pit from where material for dyke construction was gained) the active floodplain could be extended. The bank zone being suitably landscaped, it would add to the wetlands of the Kapos Valley, store water during floods and create valuable habitats for nature conservation.

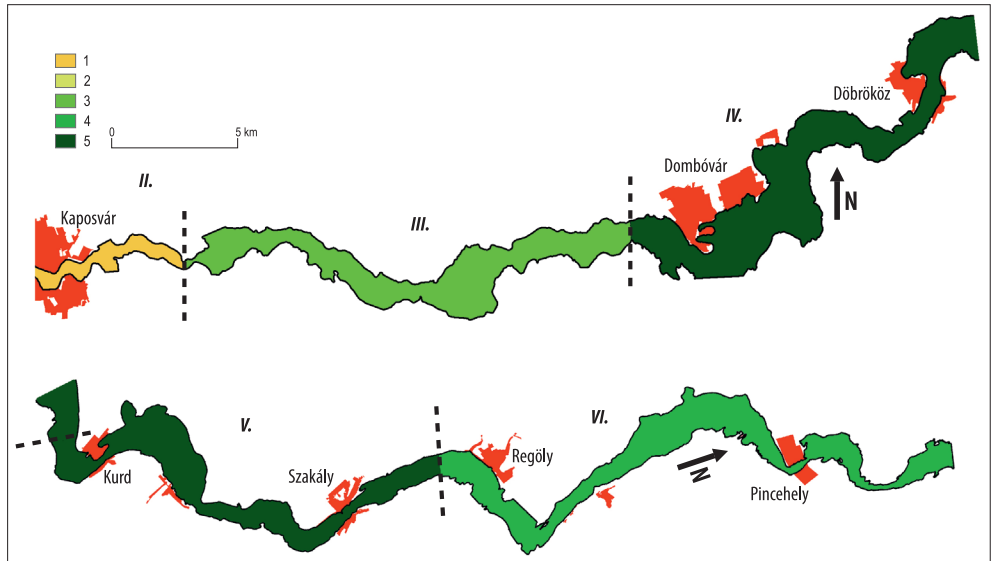
Fig. 3. Rating the rehabilitation potential of the various hydromorphological sections of the Kapos floodplain (by Lóczy, D.). The floodplain sections are identified according to Lóczy, D. (2012). II–VI = floodplain sections (river section I. has no floodplain); 1–5 = rehabilitation potentials (1 = lowest; 5 = highest one).

The assessment of the rehabilitation potential is primarily based on the opportunities for floodwater retention and flood risk reduction (see Lóczy, D. 2013). The results show that the rehabilitation proposals should focus on floodplain segments IV and V (*Figure 3*),

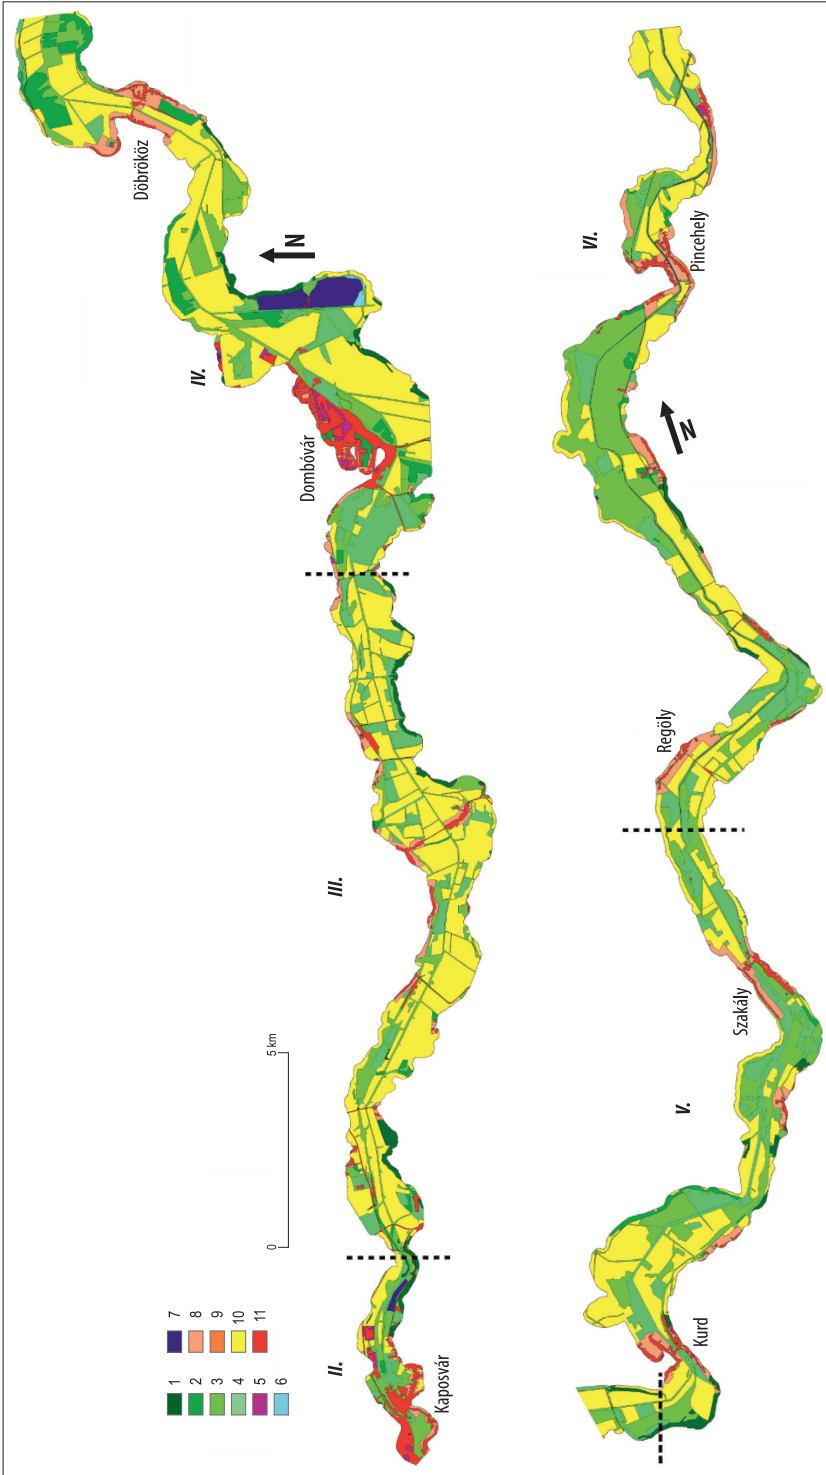
Fig. 4. Land use map of the Kapos floodplain (by GYENISZE, P.). 1 = close-to-natural forest; 2 = other forest (tree plantation); 3 = shrubs, tree rows; 4 = meadows; 5 = green area in settlement; 6 = waterlogged area, reed-bed; 7 = fish-pond; 8 = garden, orchard; 9 = vineyard; 10 = arable land; 11 = built-up area.
