CENTURIAL CHANGES IN THE DEPTH CONDITIONS OF A REGULATED RIVER: CASE STUDY OF THE LOWER TISZA RIVER, HUNGARY

Gabriel Jonathan Amissah^{1*}, Timea Kiss¹, Károly Fiala²

Research article, received 1 March 2017, accepted 26 May 2017

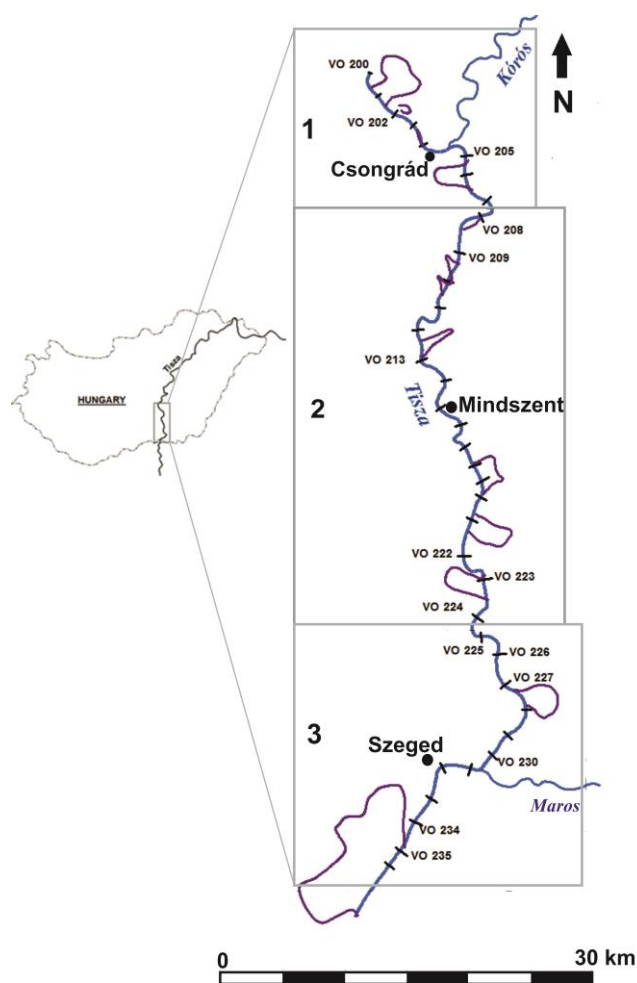
Fig. 1 The studied Tisza section was divided into three reaches based on the morphology of the channel. The studied cross-sections (1-upper reach; 2-middle reach; 3-lower reach) and cut-offs are also indicated.

(166 f.km). Based on the degree of human impact and the morphological characteristics, the section was divided into three reaches (Table 1).

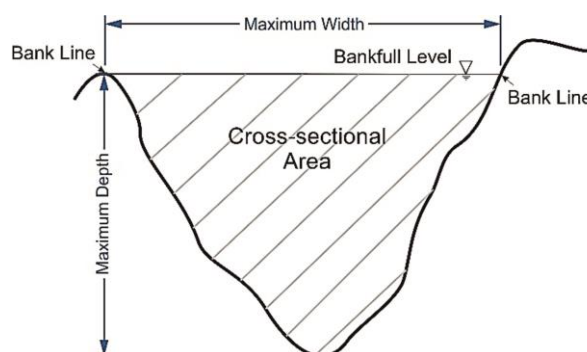
Fig. 2 The depth values were measured from the bankfull level of a cross-section

To understand the channel depth changes caused by direct human impacts, the maximum and mean depths along cross-sectional profiles were measured and analyzed. The study employed a dataset of hydrological surveys made in 1891, 1931, 1961, 1976 and 1999. The Hydrological Atlas of the Lower Tisza (1974) provided the locations of the surveyed cross-sections and it also showed the bank lines of the river at different dates. The channel surveys were undertaken using fixed geodetic survey points (VO-stones) at approximate spacing of 2.5 km. These VO-stones allowed subsequent surveys at the same cross-sectional profiles at different times. Along a profile the channel depth was measured at 5 m intervals. In the present study relative depths were calculated from the bankfull level, which was determined as lowest point of the bank line (Fig. 2). Based on the cross-sectional profiles the maximum (thalweg) depth and the mean depth for every cross-section were determined. The maximum depth refers to the location of the thalweg. The mean depth was calculated as the arithmetic mean of all depth data of a cross-section.

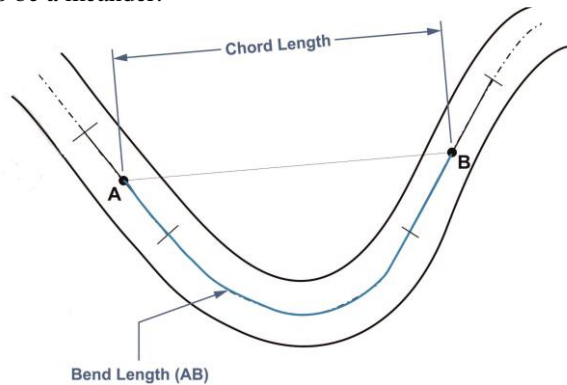
Fig. 3 Determination of inflection points, bend length and chord length along the segments of the river

of segments was calculated between two inflection points, as the ratio of bend length and chord length (Fig 3). If the sinuosity value was below 1.1, the segment was classified as a bend, if it was above 1.1 the segment was considered to be a meander.

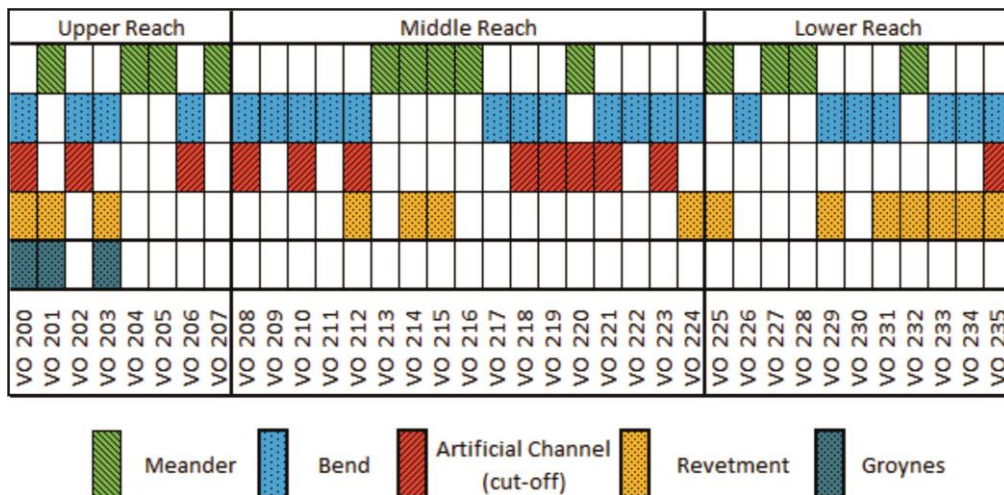
Fig. 4 The studied cross-sections are located in meanders or bends, and various human interventions affected most of their development

A general overview of the studied 36 cross-sections (Fig. 4) indicates that 64% of them are located in slightly sinuous bends, whilst the remaining 36% are situated in meanders. Also, ca. two-third of the cross-sections was under some kind of direct human influence, and only one-third (13) of them is free from direct engineering works, indicating heavy anthropogenic impact on the Lower Tisza River. The cross-sections free from any direct regu

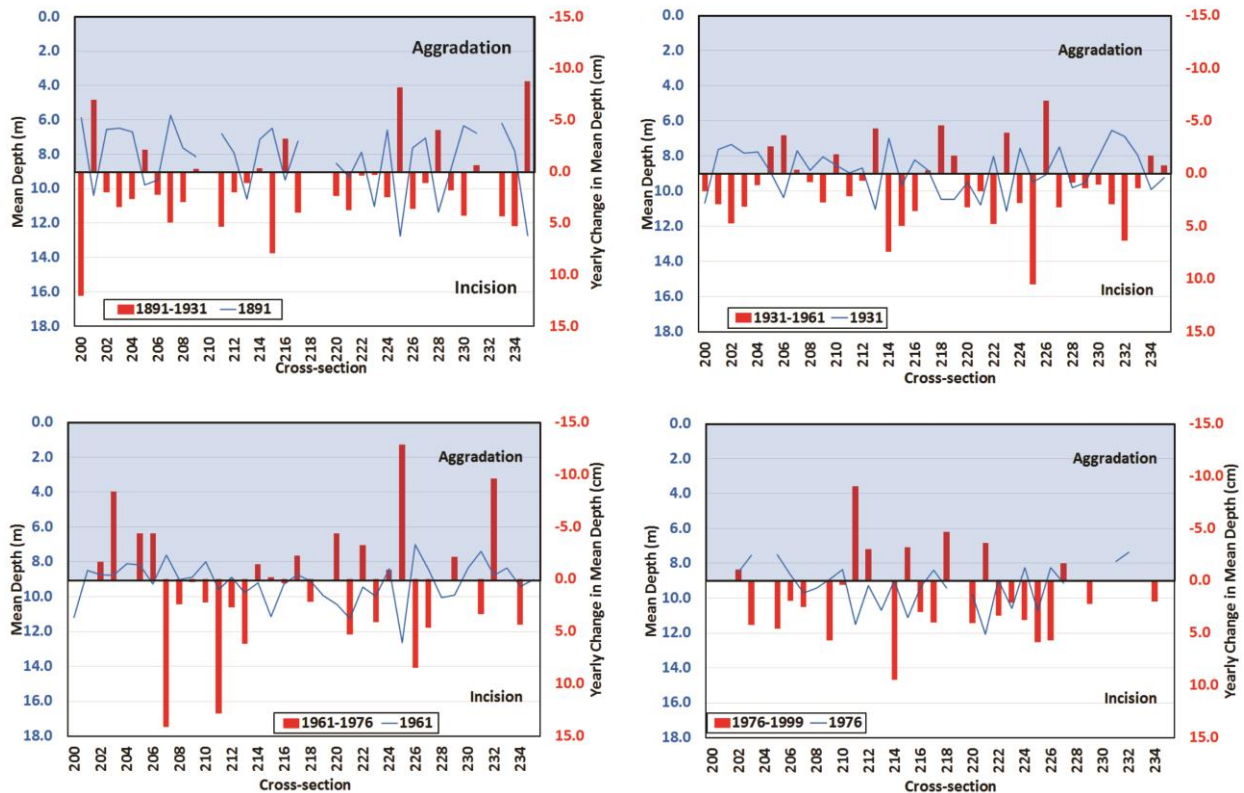
Fig. 5 Changes in mean depth: the mean depth at the beginning of a period between two surveys indicated by blue line; and the yearly change in mean depth in between survey years is indicated by red columns

A more detailed analysis of the changes of the mean depth along the studied section (Fig. 5) shows that the location of the greatest incision rates changed by time. While between 1891 and 1931 the greatest incision (12 cm/y) appeared on the upper reach (VO 200), in the next period between 1931 and 1961, it was in the lower reach (10.5 cm/y, VO 225). Between 1961 and 1976, it was measured in the upper reach (14.1 cm/y, VO 207), and finally the incision rate was 9.5 cm/y between 1976 and 1999 which occurred in the middle reach (VO 214). The VO 200 probably incised in response to cut-offs since it is located within an artificial channel, however the remaining sections were all located within meanders. Although most cross-sections referred to incision, some cross-sections had higher incision rates. The period 1976-1999 had its highest aggradation (15.9 cm/y) in the middle reach. The highest rates of aggradation for all the other periods (1891-1931: 8.7 cm/y; 1931-1961: 6.9 cm/y; and 1961-1976: 12.8 cm/y) occurred in the lower reach.

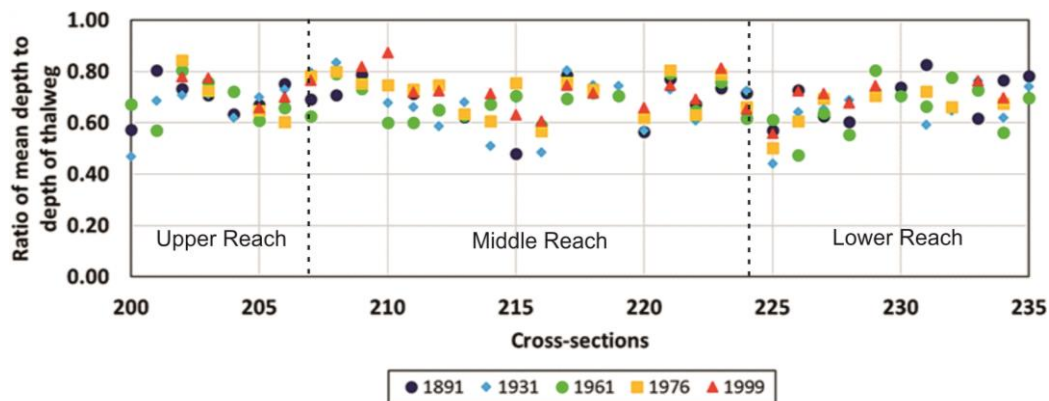
Fig. 6 The variation of the ratio of the mean depth to thalweg along the studied section

The ratio of the mean depth to the thalweg depth along the studied section of the river (Fig. 6) was also calculated, as it refers to the difference between the mean

depth and the thalweg depth: smaller value indicates a greater difference between the thalweg depth and mean depth. The ratio of mean and thalweg depths generally decrease from upstream to downstream (0.70 for upper reach; 0.69 for middle reach; and 0.67 for lower reach), referring to a more even channel bottom towards downstream. However, considering the temporal changes, it is interesting, that the ratio generally increases, referring to more intensive incision of the thalweg itself, than of the bottom of the whole channel.

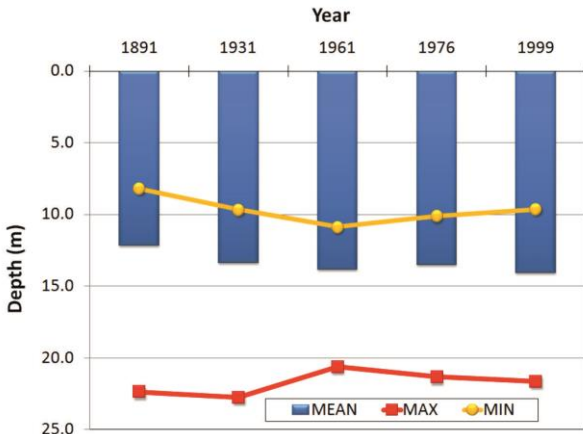
Fig. 7 Variations in mean thalweg depth for the whole studied section

During the studied period the mean thalweg depth of the whole studied section increased from 12.2 m (1891) to 14.1 m (1999), thus by 15.5 %, representing an incision rate of 1.7 cm/y over a century and indicating a general thalweg incision (Fig. 7-9). However, the incision of the

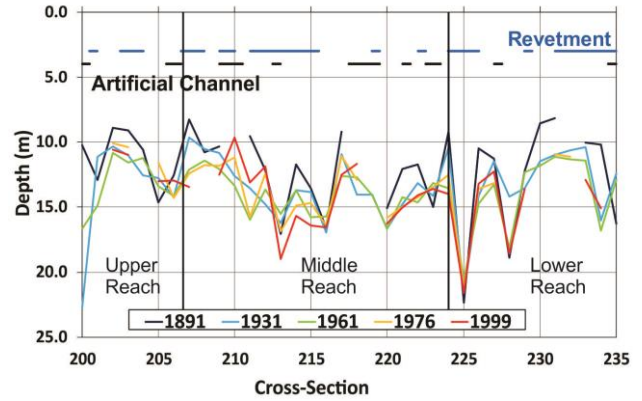
Fig. 8 Variation of thalweg depth along the studied section for various survey years

As the channel gradually developed towards quasi-equilibrium, the incision reduced (1931-1961), and the channel evolution process culminated in aggradation (1961-1976), similarly to the stages of the channel evolution model of Simon and Rinaldi (2006). The effect of high floods in the late 20th and early 21st centuries was combined with the effects of revetment and groin constructions, therefore the thalweg started to incise, thus the evolution model distorted. The range (i.e. the difference between the maximum and minimum thalweg depths) was up to 14.2 m in 1891. An increasing minimum thalweg depth and a decreasing maximum thalweg depth caused a reduction in the range until 1961. Afterwards this trend reversed, thus the range increased (1999:

12 m) was still short of the 1891 value. This reduction in ranges points to the development of a uniform channel, implying that although the channel was progressing to equilibrium after the cut-offs, the construction of the revetments and groynes initiated another cycle of dis-equilibrium.

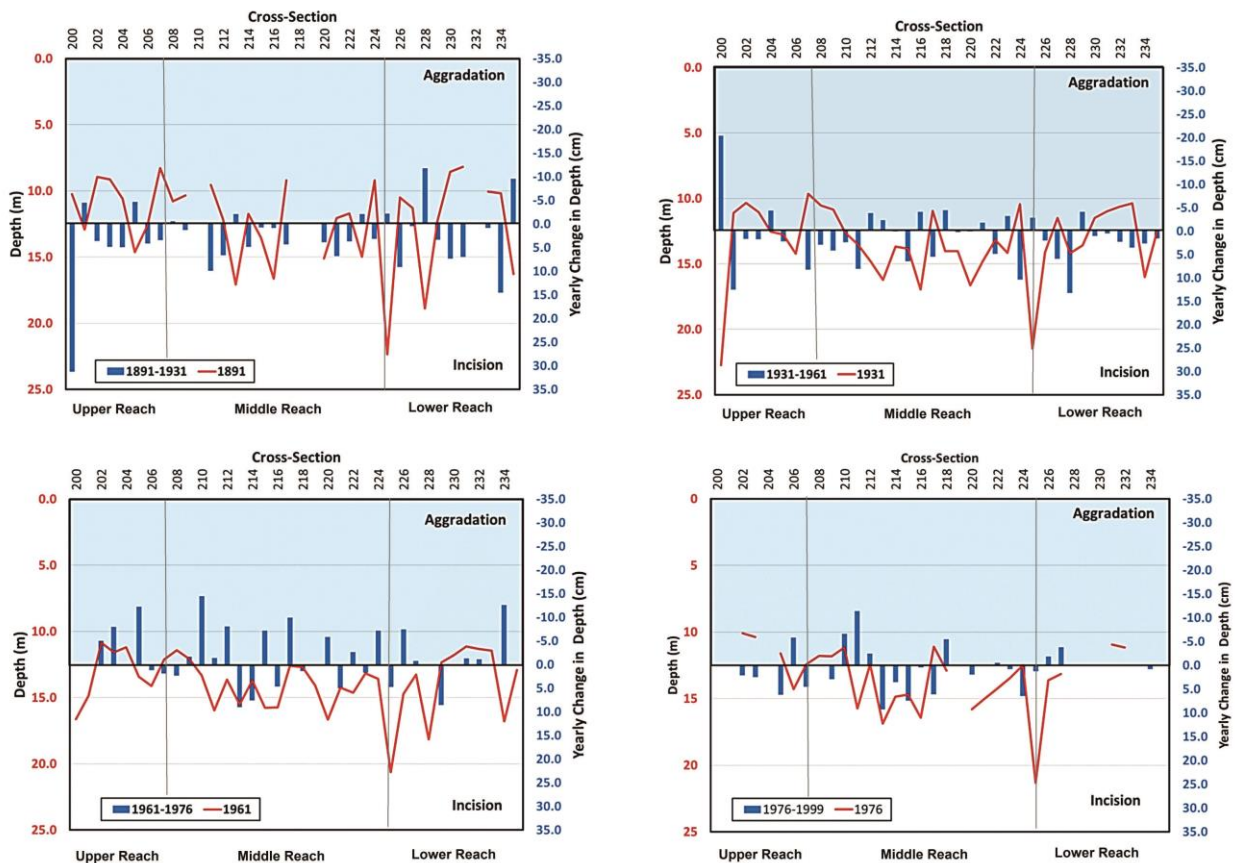
Fig. 9 Changes in thalweg depth: the thalweg depth at the beginning of a period between two surveys is indicated by red line, and the yearly change in thalweg depth in between survey years is indicated by blue columns

The spatio-temporal changes of the thalweg were studied comparing the three reaches of the Lower Tisza. The upper and middle reaches show significant changes in thalweg depth, while in the lower reach the thalweg remained relatively stable (Fig. 8). This could be explained by (i) the ponding effect of the Danube and Maros Rivers on the Tisza (Vágás, 1982) and by (ii) the artificially more stabilized and straightened lower reach. The areas of maximum incision along the channel occur mainly downstream of the cut-offs. This means the scouring action of the increased

stream power was more pronounced at the end of the artificial segments (cut-offs) of the river channel.

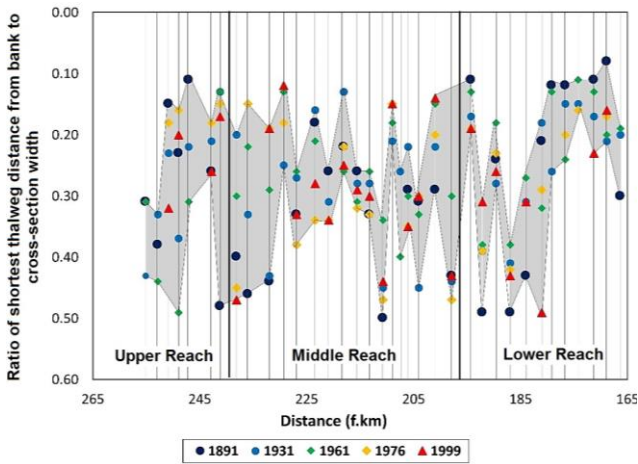
Fig. 10 Variation of the thalweg location relative to the whole cross-section width (the shaded area refers to the range of changes in the position of the thalweg)

The location of the thalweg within the cross-sectional profile was studied in detail too: the greater the ratio between the location of the thalweg to the closest bank and the channel width, the farthest is the thalweg to the banks (Fig 10). Considering the whole, ca. 100 year-long period, it seems that the thalweg migrated closer to the banks in the upper reach, whilst the changes within the middle reach are smaller, and in the lower reach the thalweg migrated away from the bank. The trends also show that the location of the thalweg had the greatest range of variations in the upper reach, referring to frequent thalweg changes: in some cross-sectional profiles the thalweg shifted almost across half of the channel width. Although along the middle reach at some cross-sections the thalweg shifts were very small, in general the lower reach had the narrowest range. This implies the lower reach was more stable compared to the middle and upper reaches, although there were some very stable locations within the middle reach.

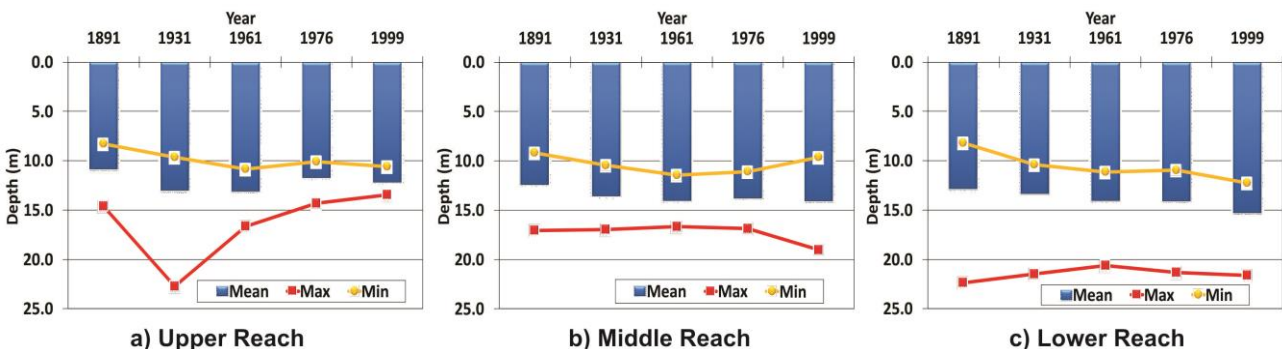
Fig. 11 Variations in thalweg depth values within the various reaches

The mean thalweg depth values of the upper reach were generally lower than the whole section, and the deepest thalweg depth was characteristic of the lower reach. The incision of the thalweg depth of the three different reaches (Fig. 11) during the whole period reflects an increasing trend towards downstream, as the mean depth of the thalweg increased by 1.3 m (1.2 cm/y) in the upper reach, by 1.7 m (1.6 cm/y) in the middle and 2.5 m (2.3 cm/y) in the lower reach.

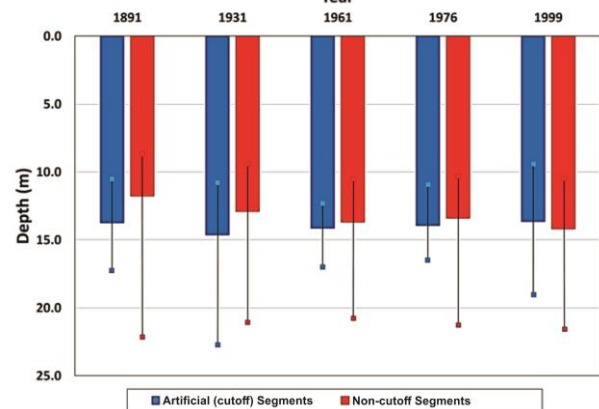
Fig. 12 Comparison of mean thalweg depths for cross-sections within segments affected and not affected by cut-offs, including the range (maximum-minimum) of thalweg depths

At the beginning, the mean thalweg depth in non cut-off segments was 11.7 m, while it was 13.7 m in artificial segments (Fig. 12). The higher mean thalweg depth in the artificial segments could be attributed to the initial scouring induced by the artificial channels of the cut-offs. However, by 1999, the mean thalweg depth in the non cut-off segments had increased by 21% to 14.2 m (2.3 cm/y), while in case of artificial segments almost zero net change was recorded. With the exception of 1961-1976 when the channel experienced a general aggradation, there was consistent incision of the mean thalweg depth within the non cut-off segments. In the artificial segments, although there was no net change between 1891 and 1999, there was a depth increase of 0.9 m from 1891 to 1931 (2.2 cm/y), which was followed by a consistent reduction of mean thalweg depth (1931-1961: 1.3 cm/y; 1961-1976: 2 cm/y and 1976-1999: 0.9 cm/y). The incision within the non-cut-off segments are partly due to the construction of revetments (80% of revetments built in segments which were not created by cut-offs) which restricted the lateral erosion within the channel, and therefore increased

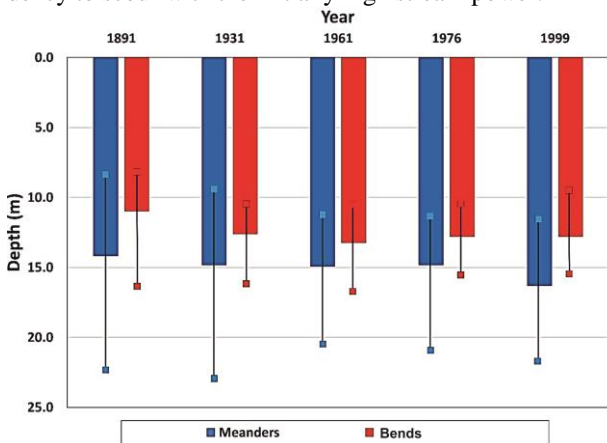
Fig. 13 Comparison of mean thalweg depths for cross-sections within meanders and bends, including the range (maximum-minimum) of thalweg depths

scouring of the channel bed to complement the sediment deficiency. Another important factor is the location of a cross-section within a meander or bend. For an alluvial channel, due to the asymmetric nature of cross-sections in meanders, thalweg depths are generally deeper in meanders than in bends or straight segments (Dey, 2014). This statement is also valid for the Lower Tisza (Fig. 13), as the mean thalweg depth of meandering segments is deeper by 3 m than of the non-meandering segments. Within the studied section, more than 90% of the meanders are located in the non-cut-off segments which contributed to its depth increments. However, the relatively narrower widths of the artificial channels also meant that the channel had the tendency to scour with the initially high stream power.

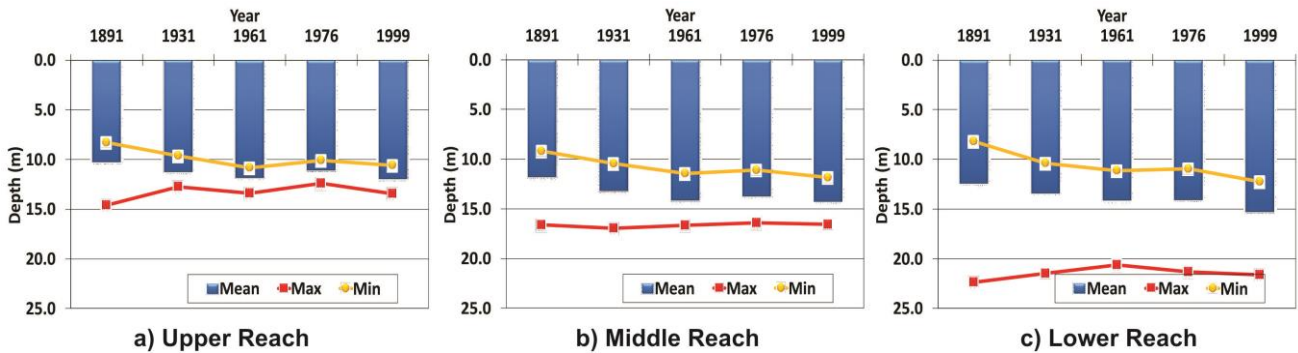
Fig. 14 Variations of the mean thalweg depth within non cut-off segments

The mean thalweg depth within the reaches followed similar trends as of the entire section for both the non cut-off and cut-off segments (Fig. 14-15) although the magnitude in the depth changes was different. For the non cut-off segments, the upper reach had the least mean depths, and the lower reach had the highest magnitudes in mean thalweg depth. In case of artificial segments, decreasing temporal trends were found in the upper and middle reaches. However, in the lower reach, there was an increasing trend in mean thalweg depth values. Another important observation is the relatively larger ranges in the non cut-off segments compared with the artificial segments.

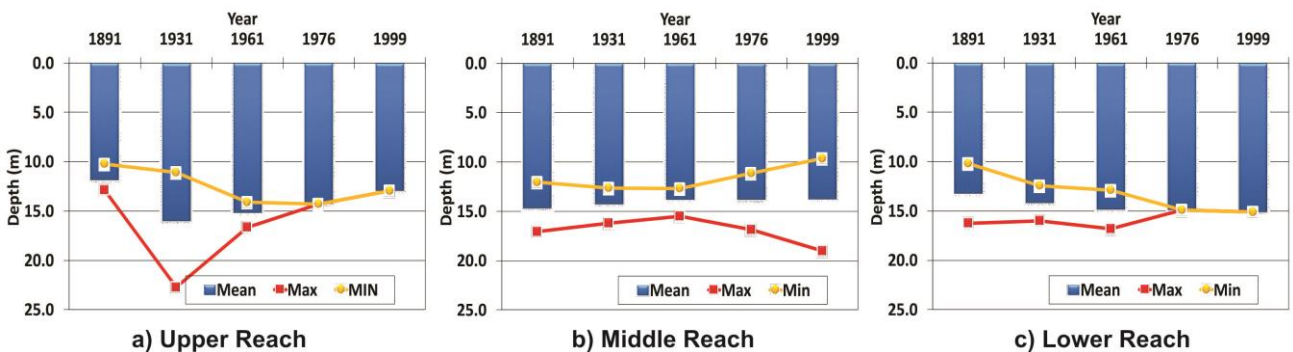
Fig. 15 Variations of the mean thalweg depth within artificial segments created by cut-offs

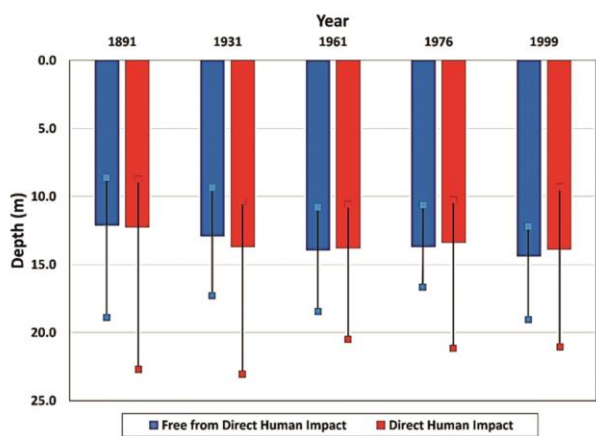
Fig. 16 Comparison of cross-sections with and without direct human impacts

When evaluating the effects of revetments and groynes in the development of the thalweg depth, it should not be forgotten, that only the combined effect of revetments, groynes and cut-offs could be studied, as they are located very close to each other, and also temporally the responses of the river on these interventions overlap. The comparison of segments without any direct human impact to the artificially altered ones reflect very similar the trends, although the segments with human impacts tend to have smaller ranges (Fig. 16). This is understandable due to the fact that they were artificially created, therefore more evenly engineered than the natural development of the non-affected channel segments. This creates more uniformity within the artificial segments compared to the natural channel segments.

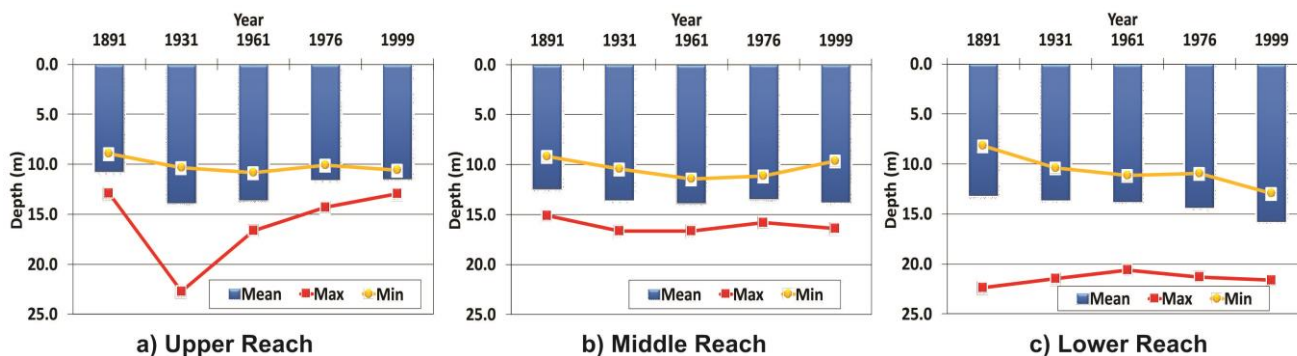
Fig. 17 Variation of the mean thalweg depth for the sections without direct human impact

Focusing on the reaches, the three reaches do not exhibit similar patterns (Fig. 17-18). The absence of clear trends shows the deficiency of generalization to responses of human impacts by rivers in some cases.

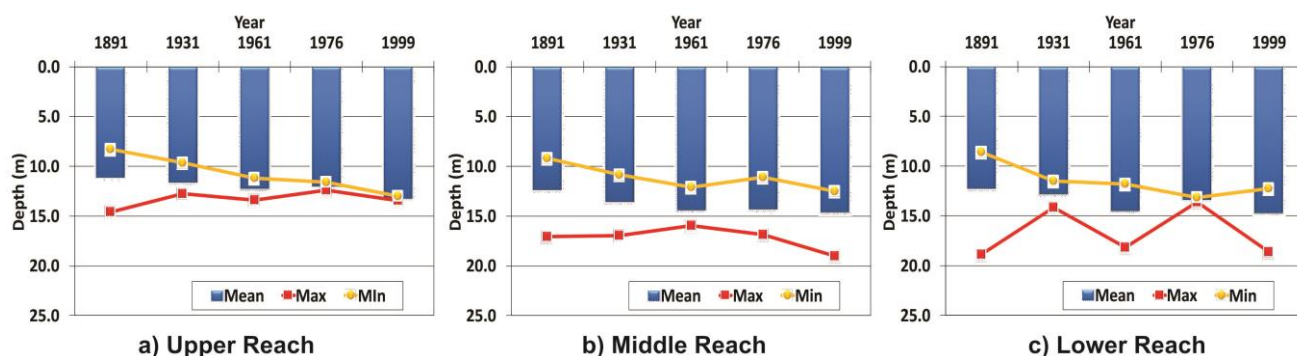
Fig. 18 Variation of the mean thalweg depth for the sections with direct human impact
